WANSON BH/INC 1200

Customer: PTRHTF40127	System Information	Sample Information
Dalco Foods B.V Everdenberg 50 Oosterhout, 4902TT Netherlands Attn: Wilbert Snijers Tel: E-Mail: w.snijers@klt.nl	System Volume: 4200 gal Bulk Operating Temp: 518F / 270C Heating Source: Blanket: Fluid: PETRO CANADA PURITY FG HEAT TRANSFER FLUID Make: WANSON	Lab No: 02386078 Analyst: Matthias Voss Sample Date: 11/02/20 Received Date: 11/09/20 Completed: 11/13/20 Matthias Voss Matthias.Voss@petrocanadalsp.com

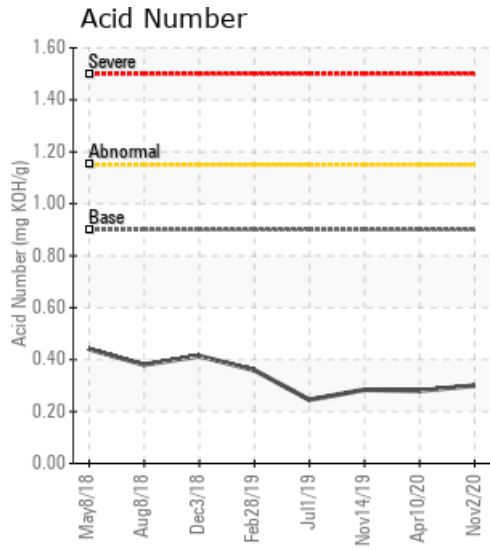
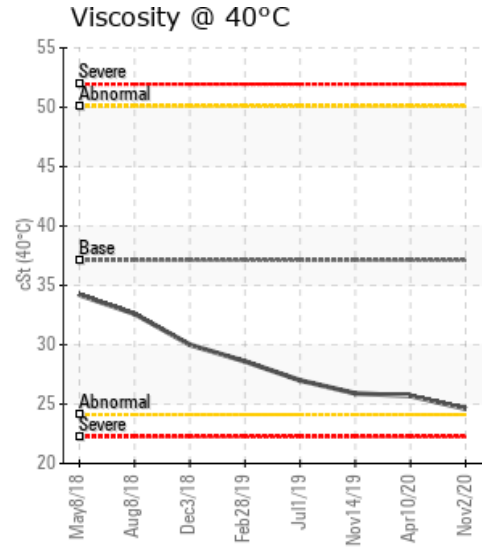
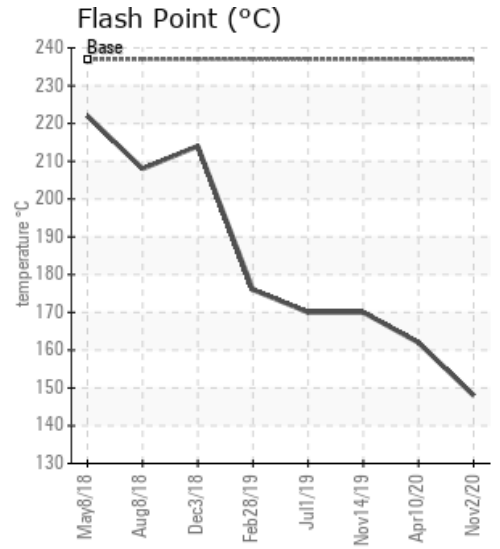
Comments: COC Flash Point is severely low. (GCD) % < 335°C is marginally high. (GCD) 10% Distillation Point is marginally low.

04/10/20	Whilst sample rating looks to have recovered, other parameters, namely Flash Point and viscosity continue to decline. Viscosity has decreased and evidence of cracking of the oil (shape of curve), also reducing flash point. Please try safe venting and check for recovery. Otherwise, operating at 270C is well above the current flash point which has reduced down to 162C. Several warnings now on flash point and if recovery attempts have failed, recommend to look towards change. Viscosity reduction is consistent and the value is distant from what we expect to see, it supports the theory of lower viscosity molecules being produced. COC Flash Point is severely low.
11/14/19	Sample continues to deteriorate. How long has the system been running as there are inconsistent values of age input against previous samples. Viscosity has decreased and evidence of cracking of the oil (shape of curve), also reducing flash point and 10% distillation. Please try safe venting and check for recovery. Otherwise, operating at 270C is well above the current flash point which has reduced down to 170C. Recommended venting and re-sample to check recovery. If continues to deteriorate look towards a change. Please, again, clarify the actual operating time as the sequence does not make sense in previous samples (GCD) 10% Distillation Point is severely low. COC Flash Point is severely low. (GCD) % < 335°C is marginally high.
