LINE 1/2

Customer: PTRHTF60002	System Information	Sample Information
BOYNE SMELTERS LTD-RIO TINTO HANDLEY DRIVE QUEENSLAND BOYNE ISLAND, QUE 4680 AUSTRALIA Attn: Heath Mitchell Tel:	System Volume: 20000 ltr Bulk Operating Temp: 514F / 268C Heating Source: Blanket: Fluid: PETRO CANADA CALFLO AF Make:	Lab No: 02393493 Analyst: Philip Riley Sample Date: 11/23/20 Received Date: 12/17/20 Completed: 01/13/21 Philip Riley philip.riley@hollyfrontier.com

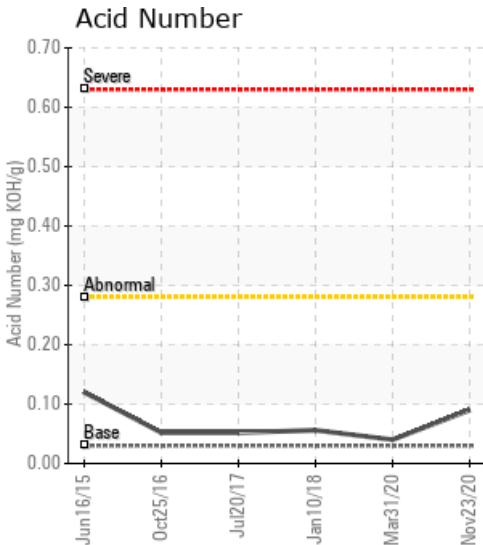
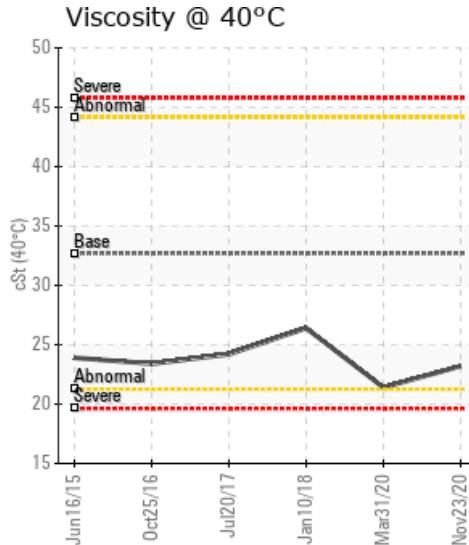
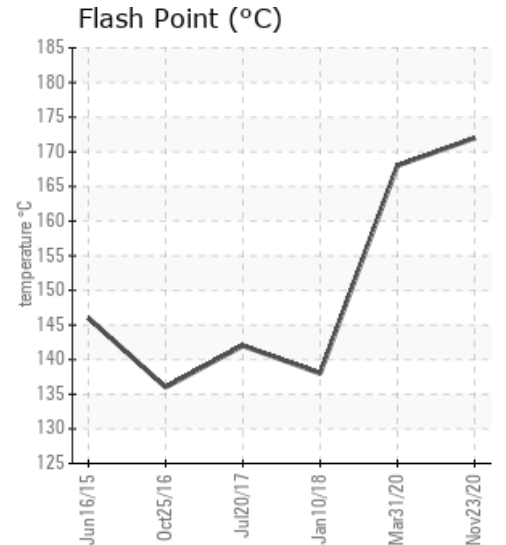
Recommendation: COC Flash Point is very low and in line with the viscosity drop showing evidence of thermal cracking of the fluid. This is further supported by the GCD curve which shows clear cracking of the fluid. If the system can be safely vented then there is the possibility to recover the flash point and remove the light ends. If it cannot be safely vented then you need to look towards a potential oil change with clean and flush. The fluid will only deteriorate further without action. The flash point has been lower and recovered and the insolubles and acid number remain low.

Historical Comments	
03/31/20	The Flash Pt has been recovered from previous samples, however remains in caution. The viscosity is very low indeed against the fresh oil. Looking at the GCD, the line shows a lot of peaks along the line, indicating thermal cracking. You must look to vent this system (safely) to remove the light end molecules. If a partial change has been done as per the last recommendation, it also indicates the fluid is heading towards end of life as the fluid seems to have a number of areas where it is deteriorating. Please conduct venting and send in another sample after 6 months max. COC Flash Point is abnormally low.
01/10/18	The current fluid has the similar conditions as the 2017 and 2016 samples. The fluid has been thermal cracked with some light boiler to reduce the flash point. Please conduct the effective system venting to release the oil vapor, or just do the 30% oil change to bring back the oil flash point and viscosity. Please take one sample in 6 months to monitor. COC Flash Point is severely low.

07/20/17	The fluid has a very similar condition as the sample in 2016. The fluid has normal acid number and solid content. However, the viscosity and flash point are all low because of the thermal cracking at 268C bulk working temperature. The effective system venting is required as soon as possible to release the light oil vapor. Please take one sample in one year to monitor the conditions.
10/25/16	The fluid flash point is severely low and the viscosity is abnormally low. The current fluid has a lot of low boiler (light end) due to the thermal cracking. The solid content, water ppm and TAN number are all normal. Please conduct the effective venting process as soon as possible to release the light end/oil vapor from the system. System venting is a recommended regular maintenance practice for any closed heat transfer system. If there is no way to vent the light end, please consider the complete fluid change or at least partial (i.e. 1/3 of the fluid) change to bring back the flash point and viscosity. Take one sample to verify the improvement after a longer and effective venting process or a partial fluid change.
