TFS H/O SYSTEM #1

Customer: PTRHTF10176	System Information	Sample Information
CERTAINTEED ROOFING	System Volume: 4462 gal	Lab No: 02395381
100 CERTAINTEED DR	Bulk Operating Temp: 553F / 289C	Analyst: Joe Goecke
JONESBURG, MO 63351 USA	Heating Source:	Sample Date: 11/22/20
Attn: Jeff Montgomery	Blanket:	Received Date: 01/04/21
Tel: (952)261-9532	Fluid: PETRO CANADA CALFLO AF	Completed: 01/06/21
E-Mail: jeffrey.d.montgomery@saint-	Make: FSE	Joe Goecke
gobain.com		Joe.goecke@petrocanadalsp.com

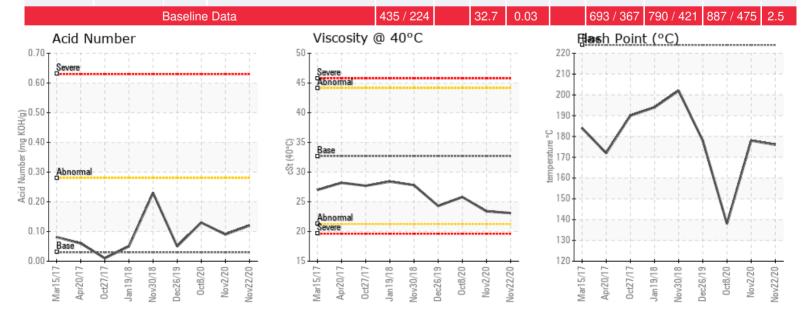
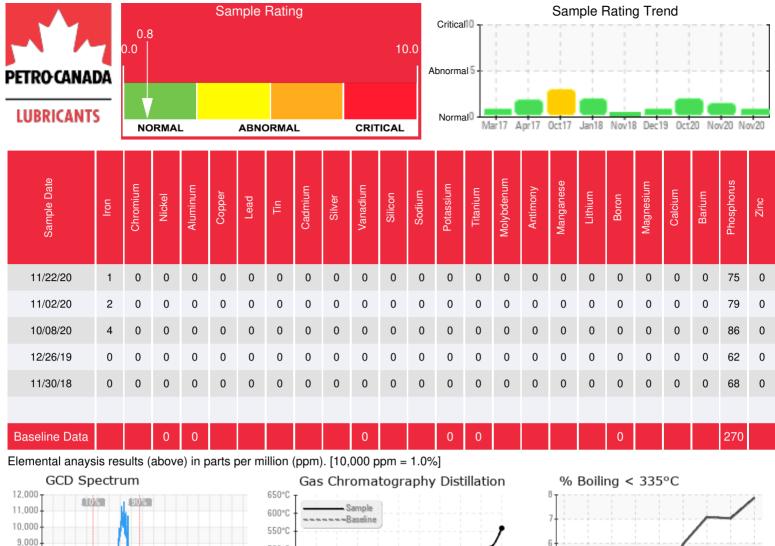
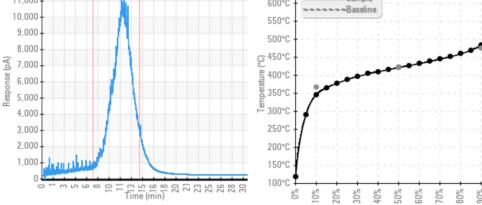
Percent Recovered

Recommendation: Sample date needs to be corrected to 12/22/20 from 11/22/20. Sample shows no significant change from last sample. A very slight increase in light ends and minor changes in viscosity and flash point. Continue to operate as normal and look to plan a venting of light ends in next quarter. Resample as scheduled.

Sample Date	Received Date	Fluid Age	Sample Location	Flash Point (COC)	Water (KF)	Viscosity (40°C)	Acid Number	Solids	GCD 10%	GCD 50%	GCD 90%	GCD % < 335°C
	mm/dd/yy			°F/°C	ppm	cSt	mg/KOH/ g	%wt	°F/°C	°F/°C	°F/°C	%
11/22/20	01/04/21	0y	Strainer	349 / 176	30.2	23.1	0.12	0.044	655 / 346	790 / 421	900 / 482	7.88
11/02/20	11/06/20	0y	Side Stream	352 / 178	11.0	23.4	0.09	0.090	665 / 352	792 / 422	901 / 483	7.03
10/08/20	10/15/20	4y	SIDE STREAM	280 / 138	17.5	25.8	0.13	0.092	664 / 351	792 / 422	901 / 483	7.08
12/26/19	09/17/20	4y	Filter	352 / 178	14.9	24.3	0.05	0.089	674 / 357	793 / 423	897 / 481	5.97
11/30/18	12/18/18	0y		396 / 202	13.8	27.8	0.23	0.054	683 / 362	791 / 422	897 / 480	3.65

11/02/20	Not much change in the light ends, but we did see a significant increase in flash point of 40 deg C. Viscosity dropped another 2 centistokes. Since the flash point has increased and we had a slight change in low boilers, I suggest continuing to run and resample next quarter with plans to change in next 90-180 days depending on next results. COC Flash Point is abnormally low.
10/08/20	Flash point is very low at 138C, as well and the light ends have continued to increase. we suggest venting this system if it has not already been done to remove light ends and increase the flash point. If not possible then a partial exchange will help. Suggest resampling after maintenance performed. COC Flash Point is severely low.
12/26/19	Sample received 9 months after taken. Low boilers on the rise and suggest venting the system if not already done flash point also slightly lower than normal. All other parameters are within spec. Timely sample submissions yield more relevant results. COC Flash Point is abnormally low.

11/30/18	This system seems to create a bit more low boilers, so it's important to vent that system more frequently so that the viscosity and flash point remain closer to fresh oil. Otherwise the oil is in great condition. The oil is within acceptable parameters.
