GFPT-FURTHER#1#2

System Information

Fluid: PETRO CANADA PURITY FG HEAT TRANSFER FLUID

Sample Information

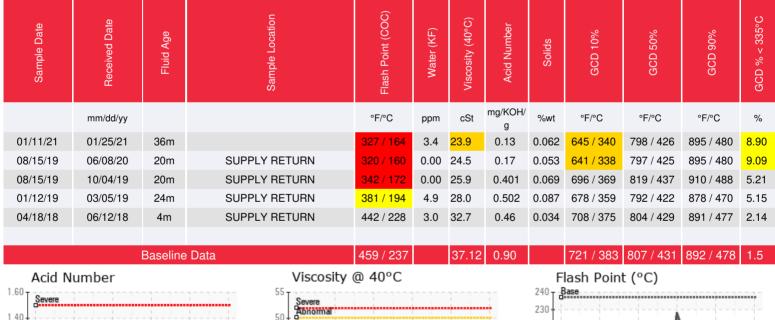
Comments: COC Flash Point is severely low. (GCD) 10% Distillation Point is abnormally low. Visc @ 40° C is abnormally low. (GCD) % < 335° C is marginally high.

Recommendation: Flash Point very low and also viscosity is also low. If the system can be vented safely then recommend this is done. Low viscosity and flash are linked and likely a result of thermal cracking, producing light end molecules of lower flash pt. Upon cracking there will also be heavy molecules and sludges formed. If flash point cannot be recovered should look towards a fluid change

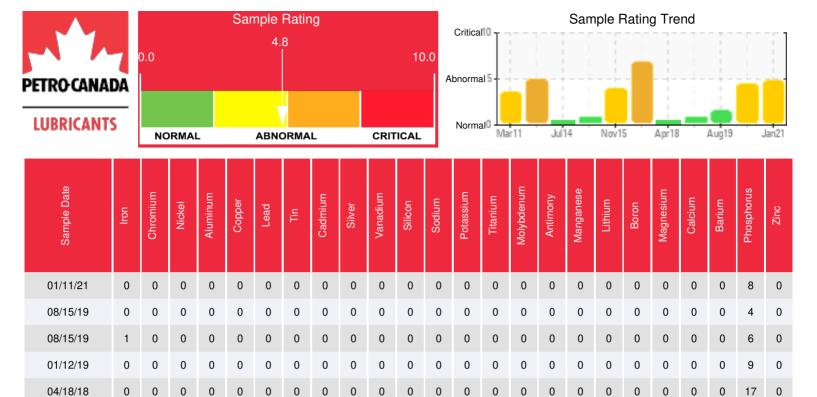
Elemental analysis results (above) in parts per million (ppm). [10,000 ppm = 1.0%]

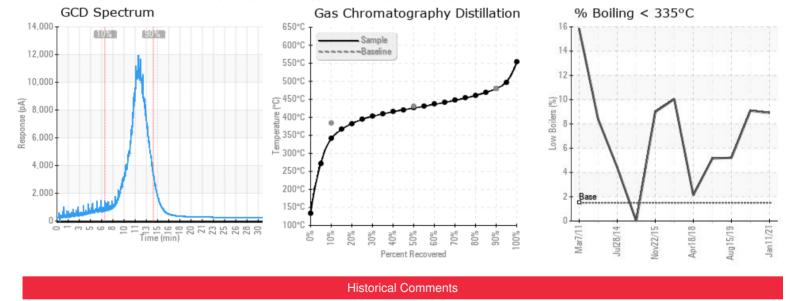
Baseline Data

The fluid has adequate viscosity, flash point, distillation points. The acid number and solid content are all low. The oil is suitable for use, please take one sample

(GCD) % < 335°C is marginally high. COC Flash Point is abnormally low. (GCD) 10% Distillation Point is marginally low. Their is some evidence of thermal cracking which causes the light boiling molecules that reflect in the low flash point, and abnormal GCD. This is supported by the low viscosity also. System venting (if it can be done safely) is required as soon

as possible, otherwise the partial oil change is recommended. COC Flash Point is severely low. (GCD) 10% Distillation Point is abnormally low. (GCD) % < 335°C is marginally high. Viscosity trending towards low and COC Flash Pt very low. If the product can be safely vented to remove light molecules this should be done and a sample taken
