HEAT TRANSFER

Customer: PTRHTF10244	System Information	Sample Information
Oneok Hydrocarbon 1910 S Broadacres Rd Hutchinson, KS 67501 USA Attn: Jason Henderson Tel: (620)899-1167 E-Mail: jason.henderson@oneok.com	System Volume: 10000 gal Bulk Operating Temp: 485F / 252C Heating Source: Blanket: Fluid: EASTMAN THERMINOL 55 Make: BROACH	Lab No: 02413749 Analyst: Garrett Bapp Sample Date: 03/31/21 Received Date: 04/07/21 Completed: 04/21/21 Garrett Bapp Garrett.Bapp@hollyfrontier.com

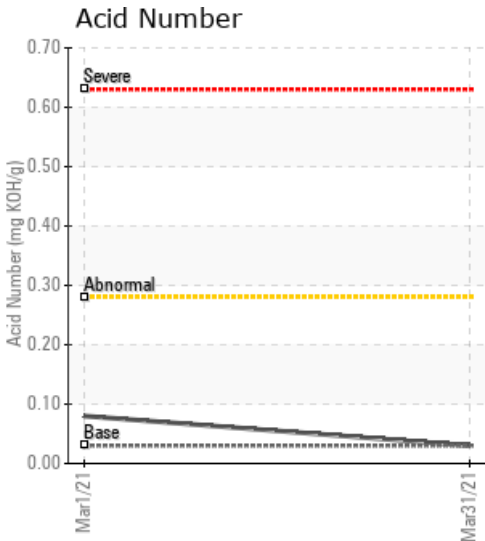
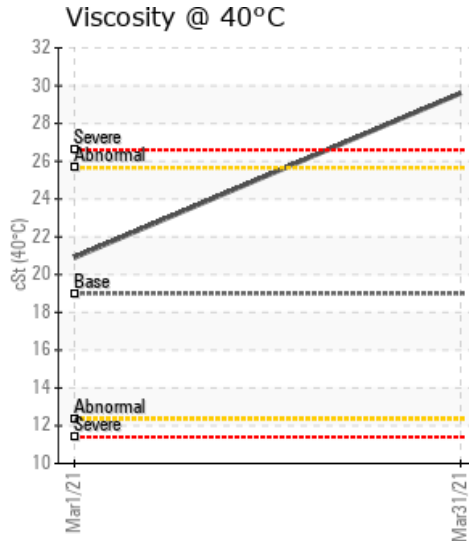
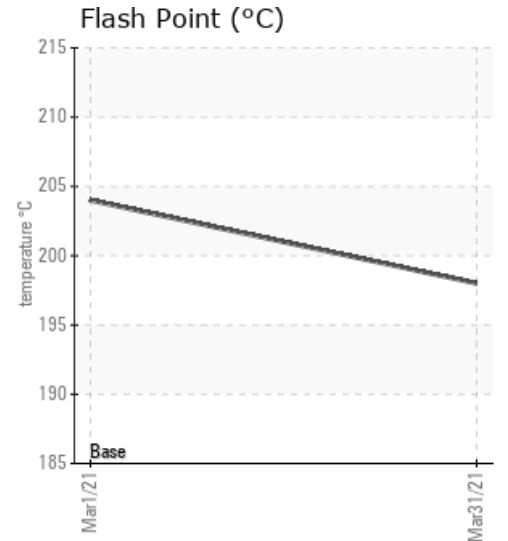
Sample Date	Received Date	Fluid Age	Sample Location	Flash Point (COC)	Water (KF)	Viscosity (40°C)	Acid Number	Solids	GCD 10%	GCD 50%	GCD 90%	GCD % < 335°C
	mm/dd/yy			°F/°C	ppm	cSt	mg/KOH/g	%wt	°F/°C	°F/°C	°F/°C	%
03/31/21	04/07/21	0.0y	low point outlet	388 / 198	10.8	29.6	0.03	0.049	646 / 341	760 / 404	886 / 474	7.40
03/01/21	03/09/21	0.0y	dischg of fltr scree	399 / 204	8.0	20.9	0.08	0.037	649 / 343	762 / 406	879 / 471	6.92
Baseline Data				349 / 176		19.0	0.03		655 / 346		790 / 421	3.40

Comments: (GCD) 90% Distillation Point is severely high. Visc @ 40°C is severely high.
