LINE 1

Customer: PTRHTF10164	System Information	Sample Information
Malarkey Roofing	System Volume: 600 gal	Lab No: 02423957
3400 S. Council Rd	Bulk Operating Temp: 565F / 296C	Analyst: Garrett Bapp
OKLAHOMA CITY, OK 73179 USA	Heating Source:	Sample Date: 05/20/21
Attn: Dillard Mathews	Blanket:	Received Date: 05/28/21
Tel: (405)261-6900	Fluid: PETRO CANADA CALFLO HTF	Completed: 06/03/21
E-Mail: dmathews@malarkeyroofing.com	Make: AMERICAN HEATING	Garrett Bapp
		Garrett.Bapp@HFSinclair.com

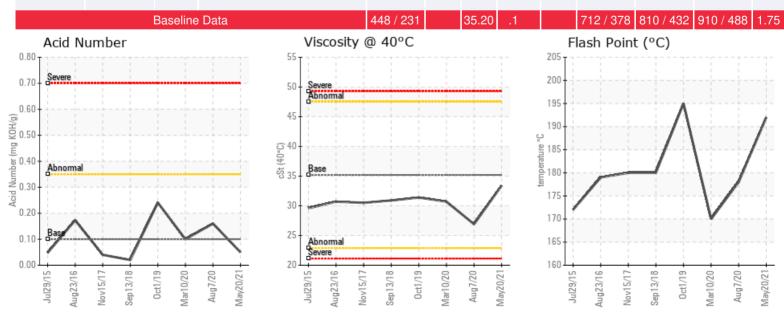
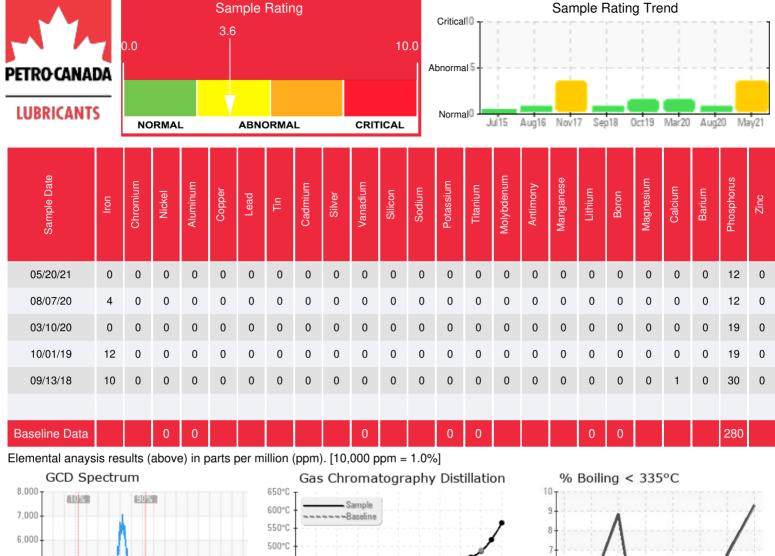
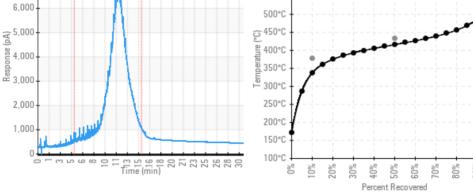
Sample Date	Received Date	Fluid Age	Sample Location	Flash Point (COC)	Water (KF)	Viscosity (40°C)	Acid Number	Solids	GCD 10%	GCD 50%	GCD 90%	GCD % < 335°C
	mm/dd/yy			°F/°C	ppm	cSt	mg/KOH/ g	%wt	°F/°C	°F/°C	°F/°C	%
05/20/21	05/28/21	4.0y	Line #1	<mark>378 / 192</mark>	11.9	33.4	0.05	0.098	638 / 337	780 / 416	905 / 485	9.29
08/07/20	08/20/20	8.0y	EXIT EXCHANGE PORT	352 / 178	25.7	26.9	0.16	0.065	674 / 356	803 / 428	917 / 492	6.74
03/10/20	04/06/20	8.0y	SAMPLE PORT	338 / 170	6.5	30.7	0.10	0.154	697 / 370	805 / 430	919 / 493	3.72
10/01/19	10/15/19	5.0y		383 / 195	12.8	31.4	0.241	0.210	726 / 386	821 / 438	936 / 502	0.00
09/13/18	10/18/18	6.5y		356 / 180	16.5	30.9	0.02	0.054	705 / 374	791 / 422	895 / 480	0.36

Recommendation: Thermal degradation of the fluid represented by GCD %<335°C, lower than normal COC Flash Point and Low GCD 10%. All other parameters are on spec. Recommended to vent light ends from the system and sweeten with 20% fluid volume.

Comments: (GCD) 10% Distillation Point is abnormally low. (GCD) % < 335°C is marginally high. COC Flash Point is marginally low.
