WANSON BH/INC 1200

Customer: PTRHTF40127	System Information	Sample Information
Dalco Foods B.V Everdenberg 50 Oosterhout, 4902TT Netherlands Attn: Wilbert Snijers Tel: E-Mail: w.snijers@klt.nl	System Volume: 4200 gal Bulk Operating Temp: 518F / 270C Heating Source: Blanket: Fluid: PETRO CANADA PURITY FG HEAT TRANSFER FLUID Make: WANSON	Lab No: 02436771 Analyst: Bill Quesnel CLS,OMA II,MLA-III,LLA-I Sample Date: 07/30/21 Received Date: 08/04/21 Completed: 08/10/21 Bill Quesnel CLS,OMA II,MLA-III,LLA-I

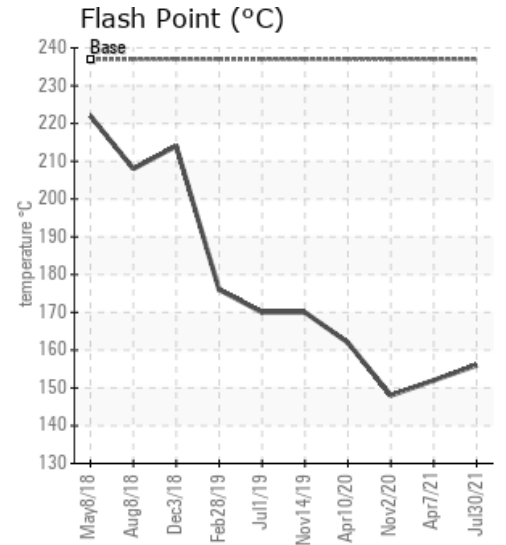
Comments: COC Flash Point is severely low. (GCD) 10% Distillation Point is abnormally low. (GCD) % < 335°C is marginally high.

Historical Comments	
04/07/21	Flash Point continues to be very low. Viscosity has decreased and evidence of cracking of the oil. Viscosity reduction is consistent and the value is distant from what we expect to see, it supports the theory of lower viscosity molecules being produced. Please try safe venting and check for recovery. Several warnings now on flash point and if recovery attempts have failed, recommend to look towards change. (GCD) 10% Distillation Point is severely low. COC Flash Point is severely low. (GCD) % < 335°C is abnormally high. Visc @ 40°C is abnormally low.
11/02/20	Flash Point (COC) is very low and off specification. Recommend venting the system in order to reduce number of low boilers and recover flash point. COC Flash Point is severely low. (GCD) % < 335°C is marginally high. (GCD) 10% Distillation Point is marginally low.
04/10/20	Whilst sample rating looks to have recovered, other parameters, namely Flash Point and viscosity continue to decline. Viscosity has decreased and evidence of cracking of the oil (shape of curve), also reducing flash point. Please try safe venting and check for recovery. Otherwise, operating at 270C is well above the current flash point which has reduced down to 162C. Several warnings now on flash point and if recovery attempts have failed, recommend to look towards change. Viscosity reduction is consistent and the value is distant from what we expect to see, it supports the theory of lower viscosity molecules being produced. COC Flash Point is severely low.
