[KEYERA PARTNERSHIP / 3-12-46-14W5] PLANT 2

System Information
 System Volume: 14000 ltr
 Bulk Operating Temp: 455F / 235C
 Heating Source:
 Blanket:
 Fluid: PETRO CANADA CALFLO HTF
 Make: PETROTHERM ENG.

Sample Information
 Lab No: 02449856
 Analyst: Lyle Dach
 Sample Date: 10/04/21
 Received Date: 10/13/21
 Completed: 10/19/21
 Lyle Dach
 lyle.dach@hollyfrontier.com

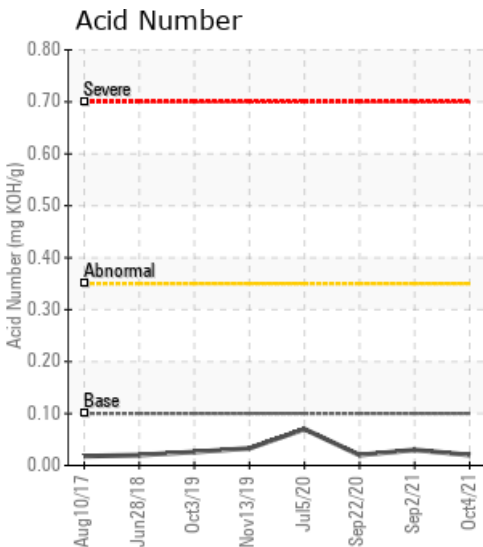
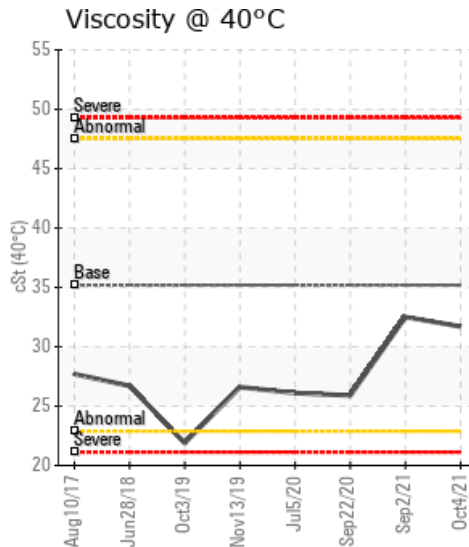
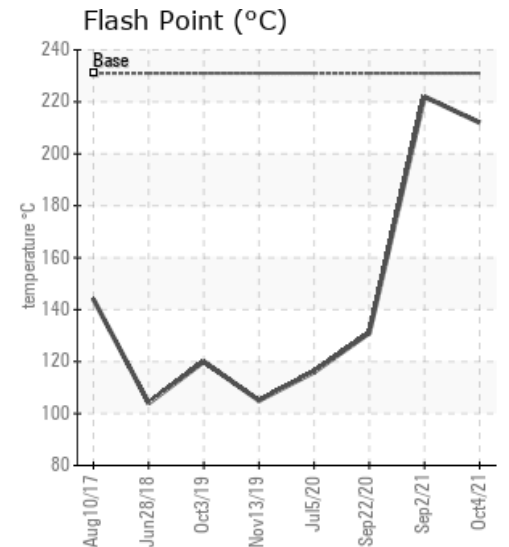
Sample Date	Received Date	Fluid Age	Sample Location	Flash Point (COC)	Water (KF)	Viscosity (40°C)	Acid Number	Solids	GCD 10%	GCD 50%	GCD 90%	GCD % < 335°C
	mm/dd/yy			°F/°C	ppm	cSt	mg/KOH/g	%wt	°F/°C	°F/°C	°F/°C	%
10/04/21	10/13/21	0.5y	after pump	414 / 212	966.8	31.7	0.02	0.441	705 / 374	805 / 429	898 / 481	2.08
09/02/21	09/20/21	14.0y		432 / 222	1255.2	32.5	0.03	0.408	707 / 375	806 / 430	900 / 482	1.70
09/22/20	09/29/20	0.0y	Slip stream filter	268 / 131	33.5	25.9	0.02	0.092	681 / 361	805 / 430	906 / 486	6.49
07/05/20	07/14/20	5.0y		241 / 116	245.8	26.1	0.07	0.030	691 / 366	808 / 431	906 / 486	5.62
11/13/19	11/20/19	0.0y	PUMP DISCHARGE	221 / 105	67.0	26.6	0.033	0.085	649 / 343	782 / 417	886 / 474	8.27
Baseline Data				448 / 231		35.20	.1		712 / 378	810 / 432	910 / 488	1.75

Recommendation: Appears to have had coolant added to the system at some point in the last year, this sample has improved from Septembers. It is best to try and boil the water off the system and vent the steam as to reduce the chance of an unwanted boil over. Excess water could also lead to corrosion issues. System fluid is Calfo AF not HTF

Comments: Potassium ppm levels are severely high. Water contamination levels are abnormally high. ppm Water contamination levels are abnormally high. Pentane Insolubles levels are abnormally high. Sodium ppm levels are severely high. Boron ppm levels are abnormally high.
