ENERGY PLANT

Customer: PTRHTF20080	System Information	Sample Information
WEST FRASER TIMBER CO LTD Hwy 584 Bag #1 SUNDRE, AB T0M 1X0 Canada Attn: BARRY BAY Tel: (403)638-1189 E-Mail:	System Volume: 110000 ltr Bulk Operating Temp: 495F / 257C Heating Source: Blanket: Fluid: PETRO CANADA PETRO-THERM Make: DELTECH	Lab No: 02449859 Analyst: Yutong Gao Sample Date: 09/28/21 Received Date: 10/13/21 Completed: 10/19/21 Yutong Gao
BARRY.BAY@WESTFRASER.COM		yutong.gao@hollyfrontier.com

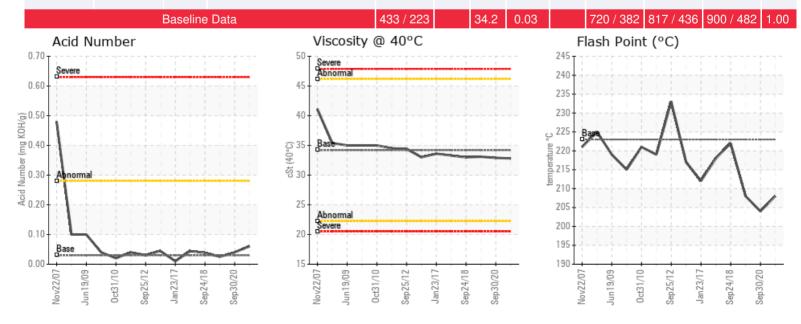
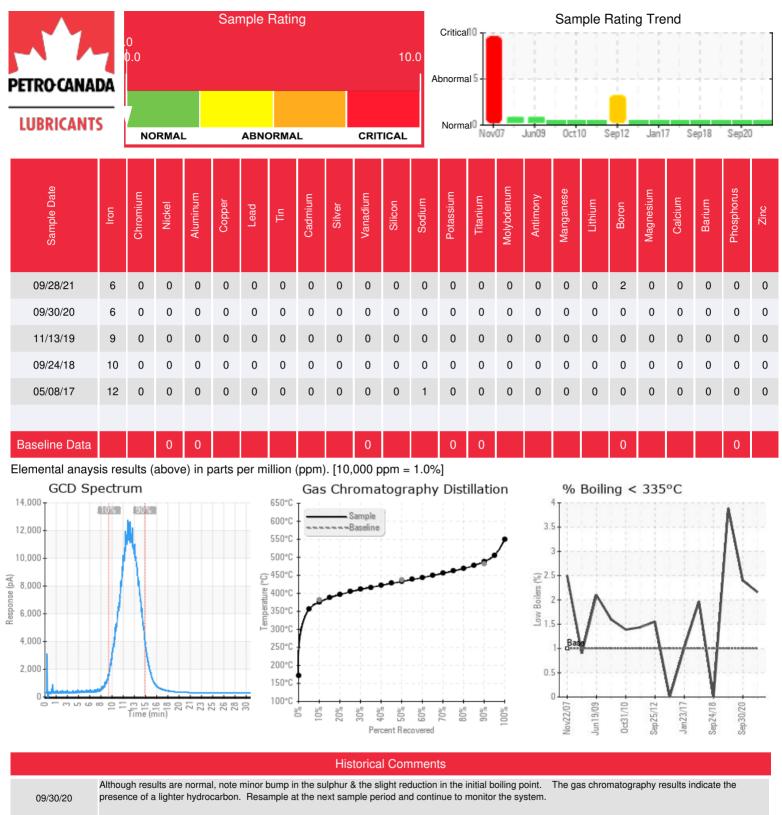
Sample Date	Received Date	Fluid Age	Sample Location	Flash Point (COC)	Water (KF)	Viscosity (40°C)	Acid Number	Solids	GCD 10%	GCD 50%	GCD 90%	GCD % < 335°C
	mm/dd/yy			°F/°C	ppm	cSt	mg/KOH/ g	%wt	°F/°C	°F/°C	°F/°C	%
09/28/21	10/13/21	14.0y	oil sample station	406 / 208	26.6	32.8	0.06	0.142	707 / 375	811 / 433	910 / 488	2.16
09/30/20	10/13/20	13.0y	OIL SAMPLE STATION	399 / 204	20.7	32.9	0.04	0.044	704 / 374	810 / 432	909 / 487	2.40
11/13/19	11/19/19	12.0y	SAMPLE STATION	406 / 208	14.9	33.1	0.025	0.050	681 / 361	792 / 422	892 / 478	3.89
09/24/18	10/02/18	11.0y		432 / 222	14.0	33.0	0.038	0.049	712 / 378	809 / 432	903 / 484	0.00
05/08/17	05/12/17	9.5y	SUCTION - BACKUP PMP	424 / 218	10.1	33.3	0.044	0.066	704 / 373	814 / 434	916 / 491	1.97

Recommendation: The sample in 2021 has very similar test results as those in 2020, 2019, etc. The current fluid has right viscosity, flash point and distillation points. The water contamination and oil oxidation are minimum. Solid content is higher than the results in previous years, but it is still considered as normal level. The fluid is suitable for further operation. Please take one sample is 12 months to monitor the conditions.
