LINE 7 HOT OIL SYSTEM

System Information

Sample Information

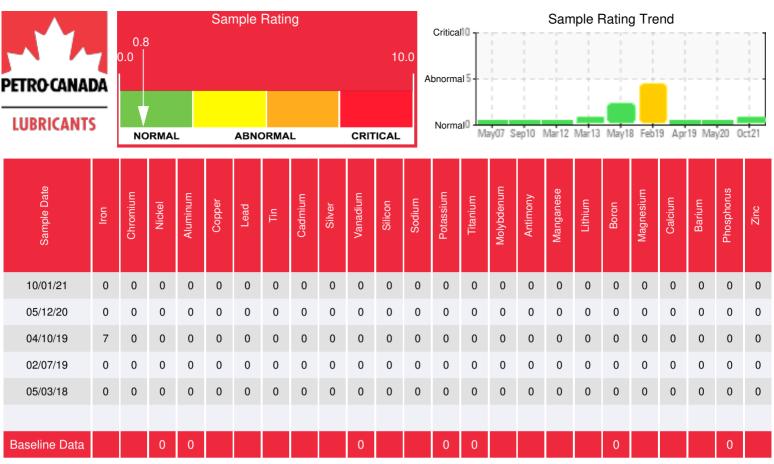
Elemental analysis results (above) in parts per million (ppm). [10,000 ppm = 1.0%]
