WANSON BH/INC 1200

Customer: PTRHTF40127	System Information	Sample Information
Dalco Foods B.V Everdenberg 50 Oosterhout, 4902TT Netherlands Attn: Wilbert Snijers Tel: E-Mail: w.snijers@klt.nl	System Volume: 4200 gal Bulk Operating Temp: 518F / 270C Heating Source: Blanket: Fluid: PETRO CANADA PURITY FG HEAT TRANSFER FLUID Make: WANSON	Lab No: 02467252 Analyst: Bill Quesnel CLS,OMA II,MLA-III,LLA-I Sample Date: 01/13/22 Received Date: 01/20/22 Completed: 01/26/22 Bill Quesnel CLS,OMA II,MLA-III,LLA-I

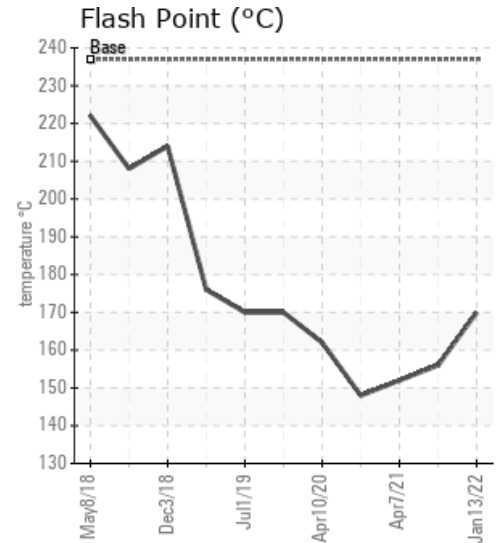
Sample Date	Received Date	Fluid Age	Sample Location	Flash Point (COC)	Water (KF)	Viscosity (40°C)	Acid Number	Solids	GCD 10%	GCD 50%	GCD 90%	GCD % < 335°C
	mm/dd/yy			°F/°C	ppm	cSt	mg/KOH/g	%wt	°F/°C	°F/°C	°F/°C	%
01/13/22	01/20/22	3.8y		338 / 170	20.2	24.6	0.30	0.145	611 / 322	792 / 422	897 / 480	10.93
07/30/21	08/04/21	3.3y		313 / 156	26.1	25.1	0.32	0.136	647 / 341	797 / 425	896 / 480	8.86
04/07/21	04/13/21	3.0y		306 / 152	22.8	23.0	0.26	0.128	592 / 311	788 / 420	908 / 486	11.83
11/02/20	11/09/20	2.5y		298 / 148	9.6	24.6	0.30	0.136	649 / 343	798 / 425	899 / 482	8.68
04/10/20	04/17/20	1.9y		324 / 162	19.3	25.7	0.28	0.065	677 / 358	800 / 427	898 / 481	6.44
Baseline Data				459 / 237		37.12	0.90		721 / 383	807 / 431	892 / 478	1.5

Comments: COC Flash Point is severely low. (GCD) 10% Distillation Point is abnormally low. (GCD) % < 335°C is marginally high.
