## [KEYERA PARTNERSHIP / 3-12-46-14W5] PLANT 2

**System Information**  
 System Volume: 14000 ltr  
 Bulk Operating Temp: 455F / 235C  
 Heating Source:  
 Blanket:  
 Fluid: PETRO CANADA CALFLO AF  
 Make: PETROTHERM ENG.

**Sample Information**  
 Lab No: 02470282  
 Analyst: Lyle Dach  
 Sample Date: 01/14/22  
 Received Date: 02/04/22  
 Completed: 02/11/22  
 Lyle Dach  
 lyle.dach@hollyfrontier.com

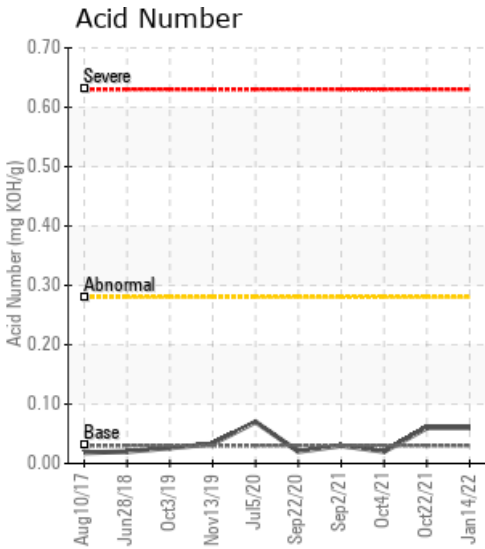
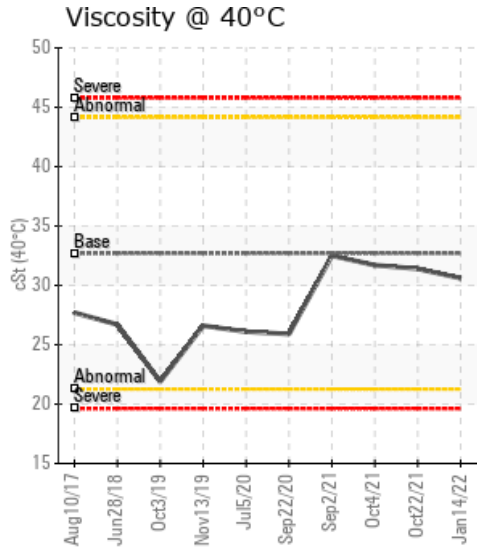
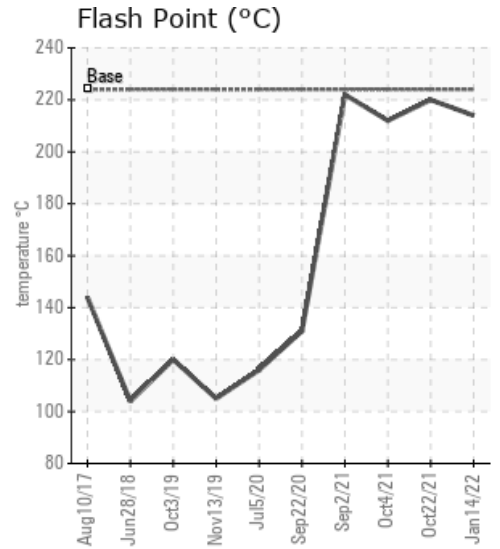
Sample Date	Received Date	Fluid Age	Sample Location	Flash Point (COC)	Water (KF)	Viscosity (40°C)	Acid Number	Solids	GCD 10%	GCD 50%	GCD 90%	GCD % < 335°C
	mm/dd/yy			°F/°C	ppm	cSt	mg/KOH/g	%wt	°F/°C	°F/°C	°F/°C	%
01/14/22	02/04/22	0.0y	hot oil pump	417 / 214	142.4	30.6	0.06	0.017	703 / 373	803 / 429	897 / 481	1.83
10/22/21	11/02/21	0.0y	HOT OIL PUMP PLANT 2	428 / 220	614.7	31.4	0.06	0.301	705 / 374	805 / 429	899 / 482	1.79
10/04/21	10/13/21	0.5y	after pump	414 / 212	966.8	31.7	0.02	0.441	705 / 374	805 / 429	898 / 481	2.08
09/02/21	09/20/21	14.0y		432 / 222	1255.2	32.5	0.03	0.408	707 / 375	806 / 430	900 / 482	1.70
09/22/20	09/29/20	0.0y	Slip stream filter	268 / 131	33.5	25.9	0.02	0.092	681 / 361	805 / 430	906 / 486	6.49
Baseline Data				435 / 224		32.7	0.03		693 / 367	790 / 421	887 / 475	2.5

Recommendation: Sample results indicate that the fluid is in suitable condition for continued service. Water content has been lowered successfully. Resample in 12 months

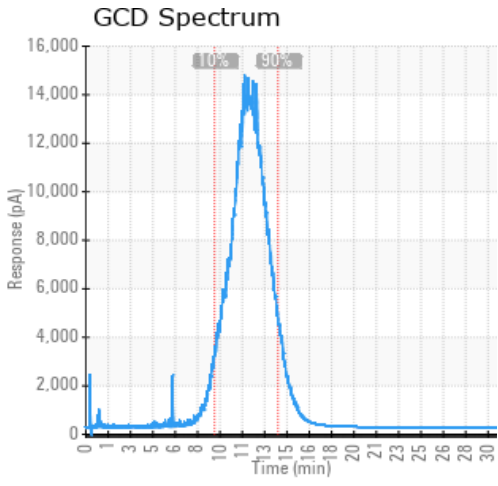
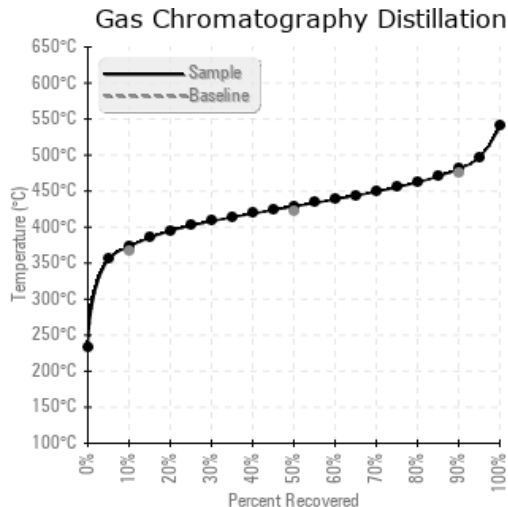
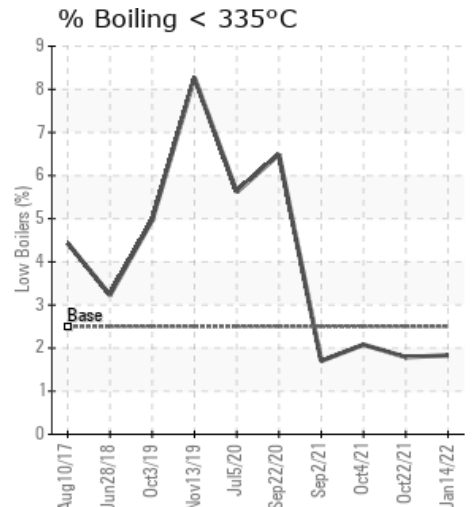
Sample Date	Iron	Chromium	Nickel	Aluminum	Copper	Lead	Tin	Cadmium	Silver	Vanadium	Silicon	Sodium	Potassium	Titanium	Molybdenum	Antimony	Manganese	Lithium	Boron	Magnesium	Calcium	Barium	Phosphorus	Zinc
01/14/22	0	0	0	0	0	0	0	0	0	0	0	0	0	0	0	0	0	0	5	0	0	0	33	0
10/22/21	8	0	0	0	0	0	0	0	0	0	0	8	18	0	0	0	0	0	12	0	0	0	75	0
10/04/21	44	0	0	0	0	0	0	0	0	0	1	46	95	0	0	0	0	0	29	1	3	0	125	0
09/02/21	41	0	0	0	0	0	0	0	0	0	2	56	258	0	0	0	0	0	40	1	3	0	134	0
09/22/20	0	0	0	0	0	0	0	0	0	0	0	0	0	0	0	0	0	0	0	0	0	0	0	0
Baseline Data			0	0						0		0	0						0				270

Elemental analysis results (above) in parts per million (ppm). [10,000 ppm = 1.0%]
