WANSON EPC 2500 ES

Customer: PTRHTF40020	System Information	Sample Information
LE DUC FINE FOOD BV	System Volume: 1500 ltr	Lab No: 02470762
MEESTER SNIJDERWEG 18	Bulk Operating Temp: 265F / 129C	Analyst: Luis Rodriguez
ZUID-HOLLAND	Heating Source:	Sample Date: 02/03/22
STELLENDAM, ZUI NETHERLANDS	Blanket:	Received Date: 02/08/22
Attn: Wilbert Snijers	Fluid: PETRO CANADA PURITY FG HEAT TRANSFER FLUID	Completed: 02/18/22
Tel:	Make: WANSON	Luis Rodriguez
E-Mail: w.snijers@klt.nl		luis.rodriguez@hollyfrontier.com

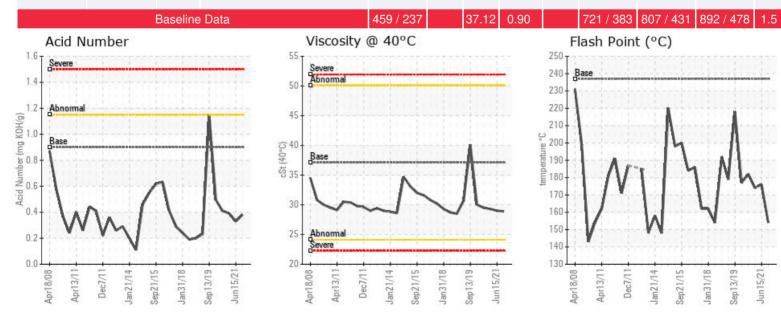
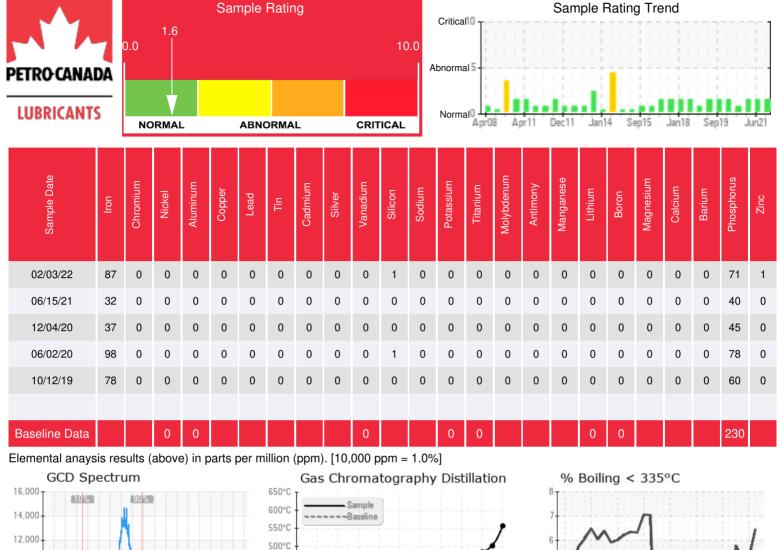
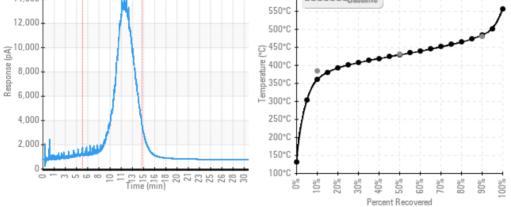
Sample Date	Received Date	Fluid Age	Sample Location	Flash Point (COC)	Water (KF)	Viscosity (40°C)	Acid Number	Solids	GCD 10%	GCD 50%	GCD 90%	GCD % < 335°C
	mm/dd/yy			°F/°C	ppm	cSt	mg/KOH/ g	%wt	°F/°C	°F/°C	°F/°C	%
02/03/22	02/08/22	7.3y		309 / 154	14.2	28.9	0.38	0.186	679 / 360	804 / 429	903 / 484	6.46
06/15/21	06/18/21	6.8y		349 / 176	15.4	29.0	0.33	0.105	694 / 368	806 / 430	906 / 486	5.22
12/04/20	12/11/20	6.3y		345 / 174	11.3	29.3	0.39	0.162	692 / 367	805 / 430	903 / 484	5.28
06/02/20	06/09/20	5.8y		360 / 182	55.0	29.5	0.41	0.289	683 / 362	804 / 429	906 / 486	5.79
10/12/19	12/23/19	5.3y		351 / 177	40.4	30.0	0.494	0.304	698 / 370	789 / 421	884 / 473	2.29

Recommendation: Flash point redone. Although the parameters of the HTF are very constant during the last year the flash point has dropped and is still abnormally low. Levels of low weight hydrocarbons recommend to monitor the low boilers and continue to perform venting, that may help to recover the flash point.
