[THAILAND] CARGILL MEAT

Customer: PTRHTF60010	System Information	Sample Information
SYNLUBE INTERNATIONAL CO LTD 76/1 MOO.7 THACHIN MUANG SAMUTSAKHON, 74000 THAILAND Attn: CHERNPORN CHOBKUI Tel: 034421290 E-Mail: chernporn@synlube.co.th	System Volume: 9225 ltr Bulk Operating Temp: 554F / 290C Heating Source: Blanket: Fluid: PETRO CANADA PURITY FG HEAT TRANSFER FLUID Make: WANSON	Lab No: 02506461 Analyst: Bill Quesnel CLS,OMA II,MLA-III,LLA-I Sample Date: 08/02/22 Received Date: 08/22/22 Completed: 08/25/22 Bill Quesnel CLS,OMA II,MLA-III,LLA-I

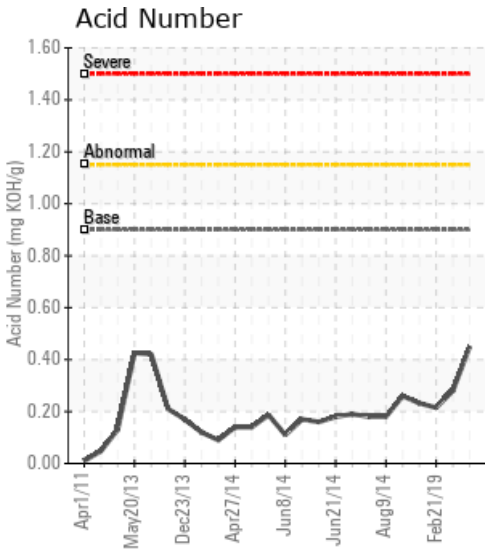
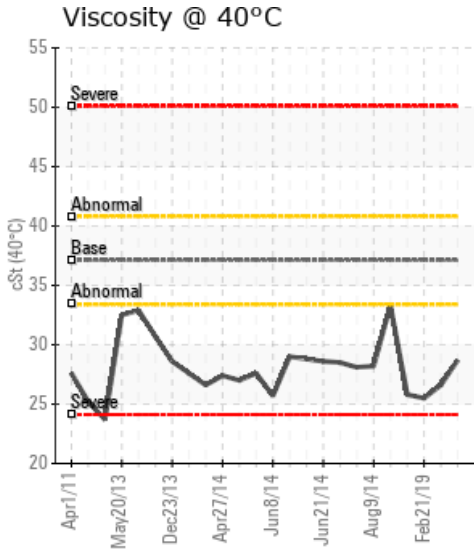
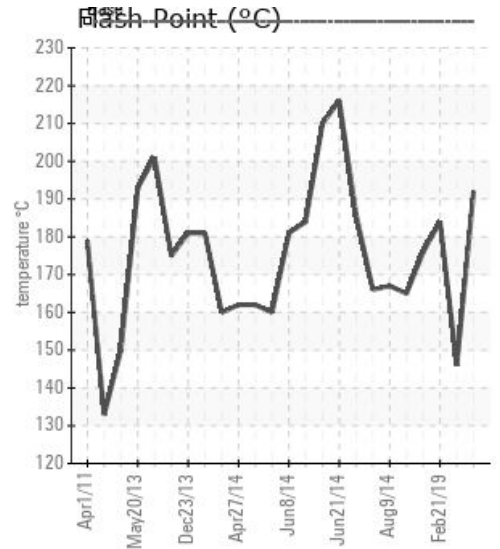
Sample Date	Received Date	Fluid Age	Sample Location	Flash Point (COC)	Water (KF)	Viscosity (40°C)	Acid Number	Solids	GCD 10%	GCD 50%	GCD 90%	GCD % < 335°C
	mm/dd/yy			°F/°C	ppm	cSt	mg/KOH/g	%wt	°F/°C	°F/°C	°F/°C	%
08/02/22	08/22/22	15.0d	SUPPLY AND RETURN	378 / 192	6.5	28.7	0.45	0.033	697 / 369	809 / 432	907 / 486	4.62
06/18/22	06/28/22	28.0d	supply and return	295 / 146	11.8	26.6	0.28	0.039	590 / 310	775 / 413	883 / 473	16.04
02/21/19	03/05/19	34.0d	RETURN	363 / 184	7.2	25.5	0.215	0.055	650 / 343	787 / 420	880 / 471	8.32
02/20/19	03/05/19	34.0d	SUPPLY	349 / 176	9.9	25.8	0.232	0.080	623 / 328	783 / 417	880 / 471	10.32
01/11/17	01/23/17	9.0d	SUPPLY/RETURN	329 / 165	9.7	33.3	0.26	0.042	688 / 364	803 / 428	897 / 480	5.05
Baseline Data				459 / 237		37.12	0.90		721 / 383	807 / 431	892 / 478	1.5

Recommendation: If system venting was carried out this has been successful in removing some low boilers and increasing the product flash point. Recommend that you perform more venting of the expansion tank to further reduce the low boilers. Resample in 6 months to monitor.

Comments: COC Flash Point is low.
