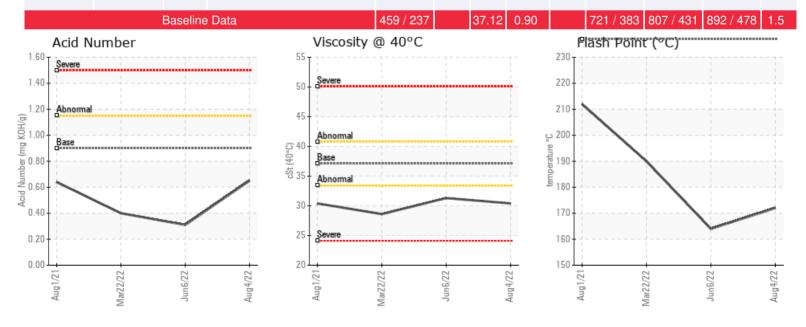
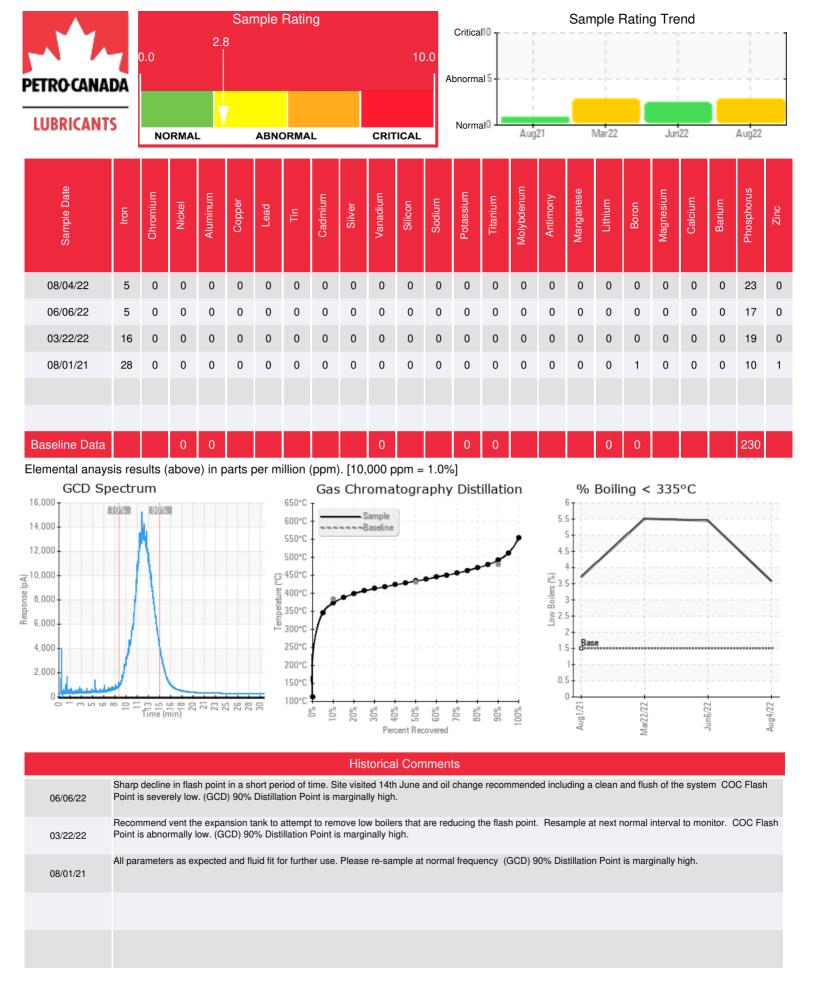
Sample Date	Received Date	Fluid Age	Sample Location	Flash Point (COC)	Water (KF)	Viscosity (40°C)	Acid Number	Solids	GCD 10%	GCD 50%	GCD 90%	GCD % < 335°C
	mm/dd/yy			°F/°C	ppm	cSt	mg/KOH/ g	%wt	°F/°C	°F/°C	°F/°C	%
08/04/22	08/22/22	24.0m	FIRER NO8 SUPPLY RTN	342 / 172	12.7	30.4	0.65	0.042	703 / 373	813 / 434	917 / 491	3.58
06/06/22	06/28/22	22.0m	Firer No. 8	327 / 164	16.8	31.3	0.31	0.049	693 / 367	813 / 434	914 / 490	5.45
03/22/22	04/05/22	19.0m	Firer No. 8	374 / 190	272.0	28.6	0.40	0.058	693 / 367	813 / 434	912 / 489	5.51
08/01/21	10/06/21	12.0m	FIRER No 8	414 / 212	48.3	30.4	0.64	0.096	712 / 378	816 / 436	911 / 489	3.71
