LINE 1/2

Customer: PTRHTF60002	System Information	Sample Information
BOYNE SMELTERS LTD-RIO TINTO HANDLEY DRIVE QUEENSLAND BOYNE ISLAND, QUE 4680 AUSTRALIA Attn: Heath Mitchell Tel:	System Volume: 20000 ltr Bulk Operating Temp: 514F / 268C Heating Source: Blanket: Fluid: PETRO CANADA CALFLO AF Make:	Lab No: 02514418 Analyst: Philip Riley Sample Date: 09/21/22 Received Date: 10/04/22 Completed: 10/07/22 Philip Riley philip.riley@HFSinclair.com

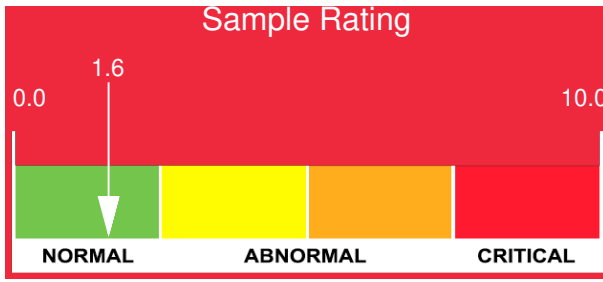
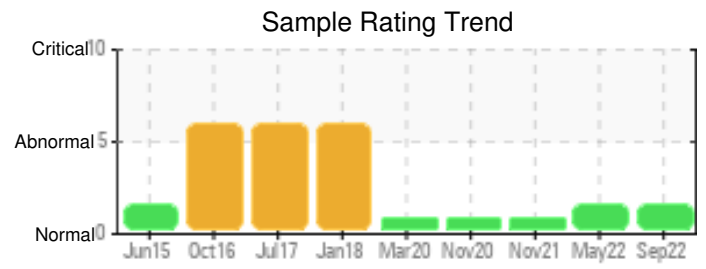
Comments: COC Flash Point is severely low.

Sample Date	Received Date	Fluid Age	Sample Location	Flash Point (COC)	Water (KF)	Viscosity (40°C)	Acid Number	Solids	GCD 10%	GCD 50%	GCD 90%	GCD % < 335°C
	mm/dd/yy			°F/°C	ppm	cSt	mg/KOH/g	%wt	°F/°C	°F/°C	°F/°C	%
09/21/22	10/04/22	30.0y		306 / 152	17.9	24.1	0.09	0.044	658 / 348	789 / 420	895 / 480	7.48
05/27/22	06/07/22	0.0y		309 / 154	15.5	23.6	0.04	0.067	662 / 350	789 / 420	893 / 479	6.89
11/24/21	12/07/21	0.0y		363 / 184	0.1	23.5	0.06	0.052	657 / 347	788 / 420	894 / 479	7.47
11/23/20	12/17/20	30.0y	rtrn near gas burner	342 / 172	20.9	23.2	0.09	0.067	659 / 348	788 / 420	894 / 479	7.30
03/31/20	07/07/20	20.0y	NEAR RETURN	334 / 168	15.3	21.4	0.04	0.062	652 / 345	788 / 420	893 / 479	7.99
Baseline Data				435 / 224		32.7	0.03		693 / 367	790 / 421	887 / 475	2.5

11/23/20	COC Flash Point is very low and in line with the viscosity drop showing evidence of thermal cracking of the fluid. This is further supported by the GCD curve which shows clear cracking of the fluid. If the system can be safely vented then there is the possibility to recover the flash point and remove the light ends. If it cannot be safely vented then you need to look towards a potential oil change with clean and flush. The fluid will only deteriorate further without action. The flash point has been lower and recovered and the insolubles and acid number remain low. COC Flash Point is abnormally low.
03/31/20	The Flash Pt has been recovered from previous samples, however remains in caution. The viscosity is very low indeed against the fresh oil. Looking at the GCD, the line shows a lot of peaks along the line, indicating thermal cracking. You must look to vent this system (safely) to remove the light end molecules. If a partial change has been done as per the last recommendation, it also indicates the fluid is heading towards end of life as the fluid seems to have a number of areas where it is deteriorating. Please conduct venting and send in another sample after 6 months max. COC Flash Point is abnormally low.
