## **MORA HE**

## System Information

Fluid: PETRO CANADA PURITY FG HEAT TRANSFER FLUID

Lab No: 02516482

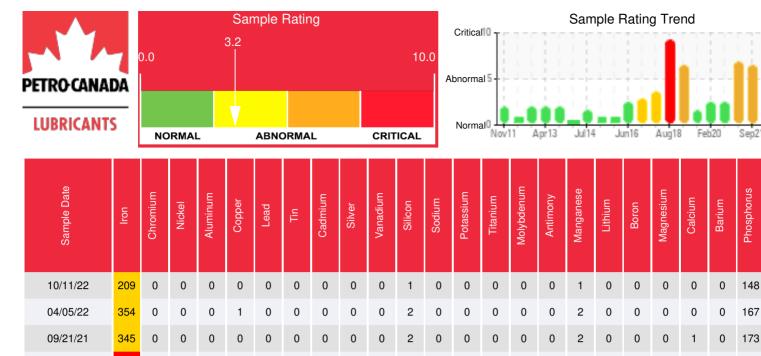
Elemental analysis results (above) in parts per million (ppm). [10,000 ppm = 1.0%]

Comments: Iron ppm levels are abnormal. Pentane Insolubles levels are abnormally high. COC Flash Point is abnormally low. (GCD) 90% Distillation Point is marginally high.

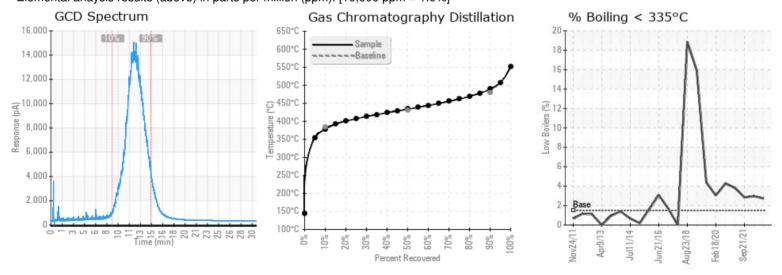
Historical Comments	
04/05/22	Likely the iron levels are from rust/scale present in the sample as a result of sampling from a low point in the system. Recommend resample in one year to monitor. Iron ppm levels are abnormal. (GCD) 90% Distillation Point is marginally high. COC Flash Point is marginally low.
09/21/21	Iron content keeps high. Is the sample taken correctly and really representative for the bulk of the system? The iron content cannot be explained with the TAN values that are OK. Otherwise the oil is fit for further use.PQ levels are severe. Iron ppm levels are abnormal. (GCD) 90% Distillation Point is marginally high. COC Flash Point is marginally low.
03/09/21	Iron content cannot be explained with the TAN values. If the system is new this could be a possible explanation, also for the previous results. Otherwise the oil is fit for further use. Iron ppm levels are severe. (GCD) 90% Distillation Point is marginally high.

09/01/20	High level of iron so please investigate the source if possible. Fit for further use and re-sample at next scheduled frequency as these are short frequencies with this systemIron ppm levels are abnormal. (GCD) 90% Distillation Point is marginally high. COC Flash Point is marginally low.
