AUTOLIV BOILER #2

System Information

Fluid: PETRO CANADA CALFLO AF

Sample Information

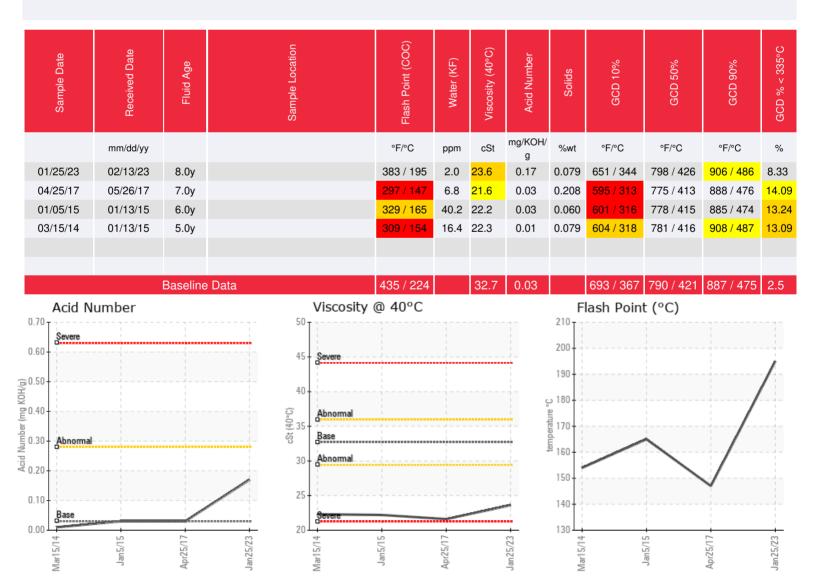
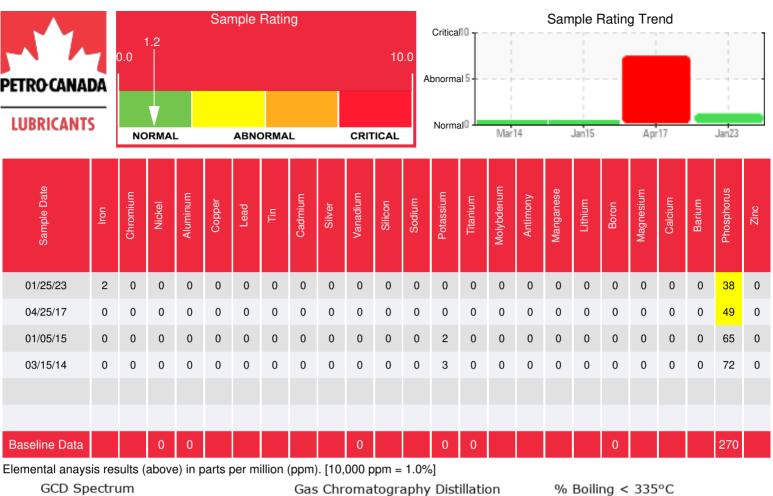
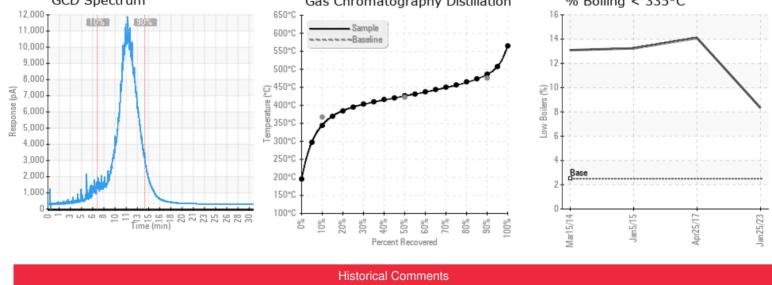
Recommendation: We can review this during our March 1st visit. Phosphorus and Sulfur levels are not normal, could there have been a top up of another product? Oil Condition: Visc @ 40°C is abnormally low. (GCD) 90% Distillation Point is marginally high.

Comments: Visc @ 40°C is abnormally low. (GCD) 90% Distillation Point is marginally high.

Viscosity of the Calflo AF has been reduced to 21.6 cSt @40°C from a typical of 32.3 cSt @ 40°C. Possible cracking of the fluid has occurred, or another product has been added. Percent of boilers <335°C is quite high @ 13.80% and 10% point has been reduced to 313.5°C from a typical of 365°C. Consider venting system to reduce light boilers. Consider bleeding off some fluid and sweetening with Calflo AF to increase viscosity of fluid. Sulphur and Phosphorus additive levels are not consistent with Calflo AF. Confirm that Calflo AF is being used and topped up.Resample at 3 months after venting to confirm if low boilers have been reduced. Consider bleeding off some fluid and sweetening with Calflo AF to increase flash point and reduce low boilers. (GCD) 10% Distillation Point is severely low. COC Flash Point is severely low. (GCD) % < 335°C is abnormally high.

There is an indication of thermal cracking as the oil seems to have abnormall high light ends. If it is possible to vent the light ends out of the system through the expansion tank, then I would suggest that this be done. I would suggest that we re-sample the oil in this unit. It is about the same as the sample from 3/5/2014
