LINE 1/2

Customer: PTRHTF60002	System Information	Sample Information
BOYNE SMELTERS LTD-RIO TINTO HANDLEY DRIVE QUEENSLAND BOYNE ISLAND, QUE 4680 AU Attn: Heath Mitchell Tel: E-Mail: heath.mitchell@riotinto.com	System Volume: 20000 ltr Bulk Operating Temp: 514F / 268C Heating Source: Blanket: Fluid: PETRO CANADA CALFLO AF Make:	Lab No: 02539379 Analyst: Philip Riley Sample Date: 01/19/23 Received Date: 02/14/23 Completed: 02/21/23 Philip Riley philip.riley@HFSinclair.com

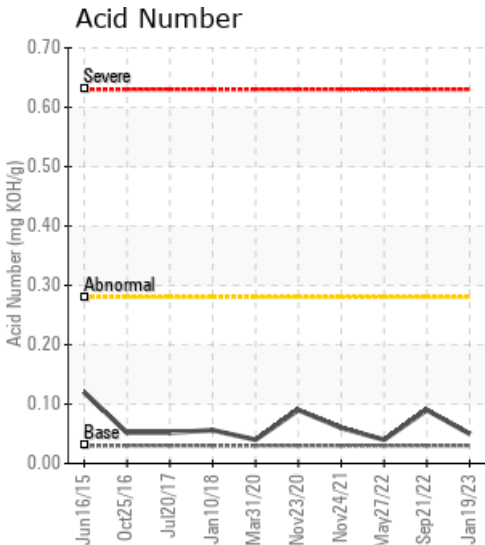
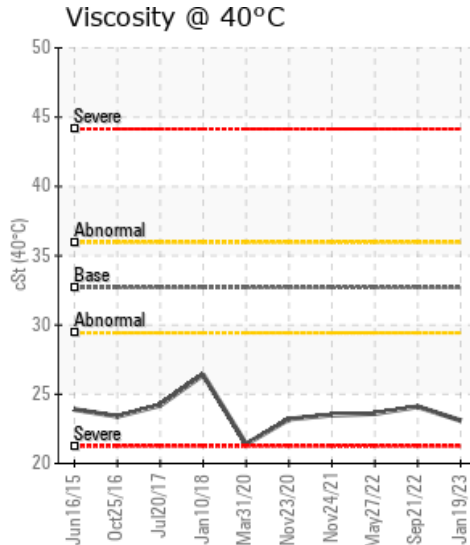
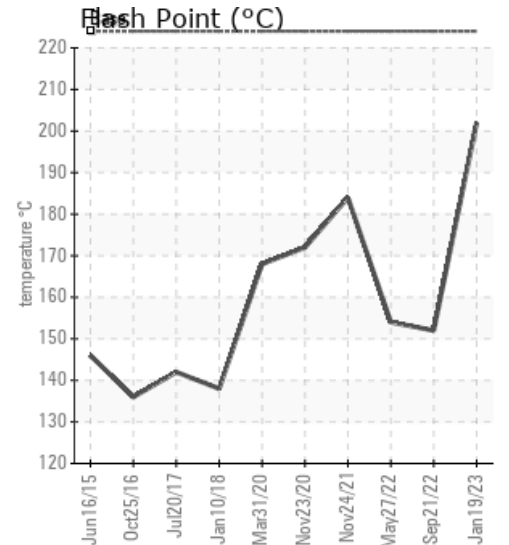
Comments: Pentane Insolubles levels are severely high. Visc @ 40°C is abnormally low.

Sample Date	Received Date	Fluid Age	Sample Location	Flash Point (COC)	Water (KF)	Viscosity (40°C)	Acid Number	Solids	GCD 10%	GCD 50%	GCD 90%	GCD % < 335°C
	mm/dd/yy			°F/°C	ppm	cSt	mg/KOH/g	%wt	°F/°C	°F/°C	°F/°C	%
01/19/23	02/14/23	20.0y	HTF Heater	396 / 202	12.0	23.1	0.05	0.937	690 / 366	799 / 426	902 / 484	4.21
09/21/22	10/04/22	30.0y		306 / 152	17.9	24.1	0.09	0.044	658 / 348	789 / 420	895 / 480	7.48
05/27/22	06/07/22	0.0y		309 / 154	15.5	23.6	0.04	0.067	662 / 350	789 / 420	893 / 479	6.89
11/24/21	12/07/21	0.0y		363 / 184	0.1	23.5	0.06	0.052	657 / 347	788 / 420	894 / 479	7.47
11/23/20	12/17/20	30.0y	rtrn near gas burner	342 / 172	20.9	23.2	0.09	0.067	659 / 348	788 / 420	894 / 479	7.30
Baseline Data				435 / 224		32.7	0.03		693 / 367	790 / 421	887 / 475	2.5

Recommendation: Partial change recovered the flash point as expected, but this is a temporary measure to get to a safe place. There is a lot of sediment in the system and the visco is running low, evidence of cracking and whilst the low boiling point molecules are removed by venting, the other forms of degradation stay behind and will affect the oil. You have pushed back the urgency and should plan a change out in the coming months, including a clean and flush of the system

11/24/21	COC Flash Point is low, but improved from the previous sample. Again, there is viscosity drop, and in line with the GCD curve, evidence of fluid cracking (when you link viscosity drop, low flash point, graph). If the system can be safely vented then there is the possibility to recover the flash point and remove the light ends. Conscious this system was changed within the last 12 months, and the results on Line 3 are distinctly different, where the fluid is in very good condition. After venting (if possible), would be interesting to see another sample to see if and how the fluid has recovered somewhat COC Flash Point is marginally low.
11/23/20	COC Flash Point is very low and in line with the viscosity drop showing evidence of thermal cracking of the fluid. This is further supported by the GCD curve which shows clear cracking of the fluid. If the system can be safely vented then there is the possibility to recover the flash point and remove the light ends. If it cannot be safely vented then you need to look towards a potential oil change with clean and flush. The fluid will only deteriorate further without action. The flash point has been lower and recovered and the insolubles and acid number remain low. COC Flash Point is abnormally low.
