## **AUTOLIV BOILER #3**

### Customer: PTRHTF30004

#### **System Information**

#### Sample Information

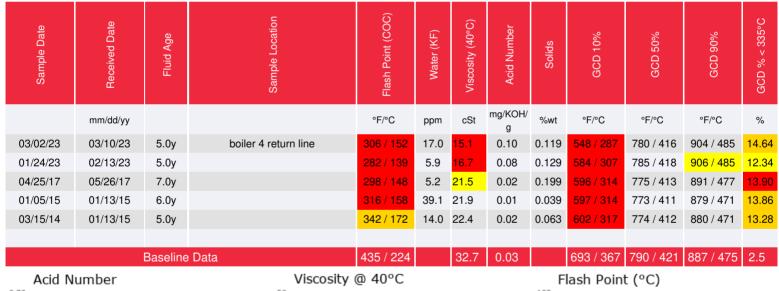
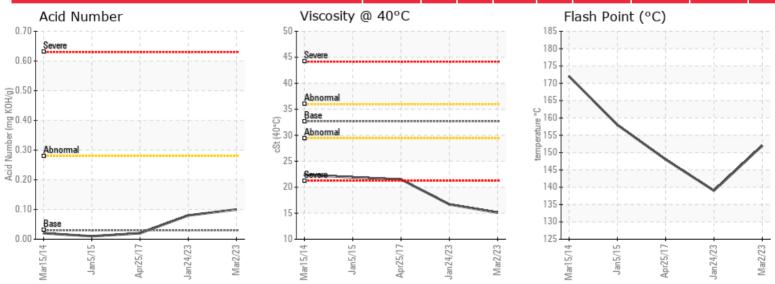
Comments: (GCD) 10% Distillation Point is severely low. COC Flash Point is severely low. Visc @ 40°C is severely low. (GCD) % < 335°C is abnormally high.

Viscosity of the Calflo AF has been reduced. Possible cracking of the fluid has occurred, or another product has been added. Percent of boilers <335°C is quite high @ 13.90% and 10% point has been reduced to 313.5°C from a typical of 365°C. Flash point has been reduced to 148°C from the normal typical of 21°C. Consider venting system to reduce light boilers. Consider bleeding off some fluid and sweetening with Calflo AF to increase viscosity of fluid. Sulphur and Phosphorus additive levels are not consistent with Calflo AF. Confirm that Calflo AF is being used and topped up. Resample at 3 months after venting to confirm if low boilers have been reduced. Consider bleeding off some fluid and sweetening with Calflo AF is increase flash point and reduced by boilers. (GCD) 10% Distillation Point is severely low. COC Flash Point is severely low. (GCD) % < 335°C is abnormally high.

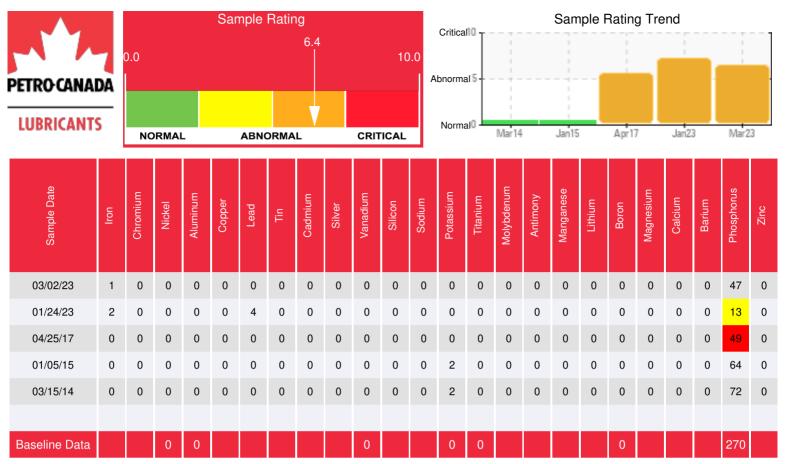
Elemental analysis results (above) in parts per million (ppm). [10,000 ppm = 1.0%]
