NEW - WANSON 450

Customer: PTRHTF40052	System Information	Sample Information
ROYAAN BV	System Volume: 800 ltr	Lab No: 02566012
HOGE MAAT 8	Bulk Operating Temp: 255F / 124C	Analyst: Bill Quesnel CLS,OMA II,MLA-
WIJK BIJ BUURSTEDE 3961 NC	Heating Source:	III,LLA-I
WIJK BIJ DUURSTEDE, 3961NC	Blanket:	Sample Date: 06/16/23
Netherlands	Fluid: PETRO CANADA PURITY FG HEAT TRANSFER FLUID	Received Date: 06/22/23
Attn: WILBERT SNIJERS	Make: WANSON	Completed: 07/07/23
Tel:		Bill Quesnel CLS,OMA II,MLA-III,LLA-I

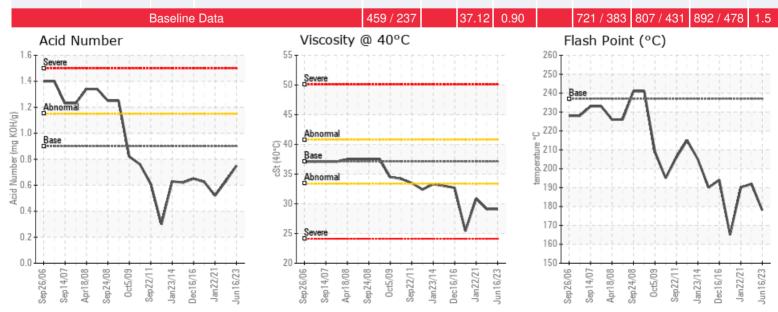
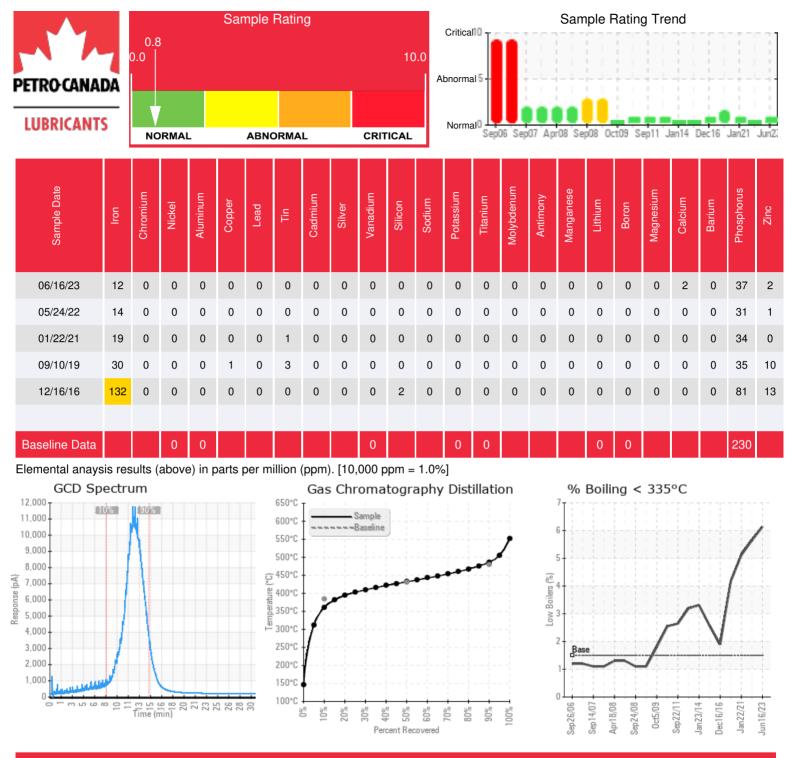
Sample Date	Received Date	Fluid Age	Sample Location	Flash Point (COC)	Water (KF)	Viscosity (40°C)	Acid Number	Solids	GCD 10%	GCD 50%	GCD 90%	GCD % < 335°C
	mm/dd/yy			°F/°C	ppm	cSt	mg/KOH/ g	%wt	°F/°C	°F/°C	°F/°C	%
06/16/23	06/22/23	16.8y		352 / 178	5.2	29.1	0.75	0.064	681 / 361	809 / 432	907 / 486	6.14
05/24/22	05/30/22	15.8y		378 / 192	33.6	29.1	0.63	0.068	685 / 363	810 / 432	910 / 488	5.64
01/22/21	01/28/21	14.0y		374 / 190	23.0	30.9	0.52	0.115	688 / 364	810 / 432	906 / 485	5.12
09/10/19	09/19/19	12.5y		329 / 165	31.5	25.4	0.625	0.029	699 / 371	819 / 437	909 / 487	4.16
12/16/16	01/27/17	10.0y		381 / 194	66.1	32.7	0.65	0.237	709 / 376	813 / 434	898 / 481	1.90
