Recommendation: Sample results indicate the system requires a cleaning, flush and re-fill with fresh heat transfer fluid due to severe oxidative degradation: Acid Number is at 2.48 (limit is 1); this is likely causing significant metal corrosion as shown by 487 ppm of Iron; fluid viscosity is 173 cSt (should be close to 35) cSt. Solids content has increased to 3.47%, indicating severe system fouling. Plans need to be made for system cleaning and fluid replacement in 2024. Please contact Petro-Canada Lubricants Tech Services for further details.

Report ID: [02606857] (Generated: 01/08/2024 16:34:14) - Page 1 - Copyright 2024 Wearcheck Inc. All Rights Reserved.

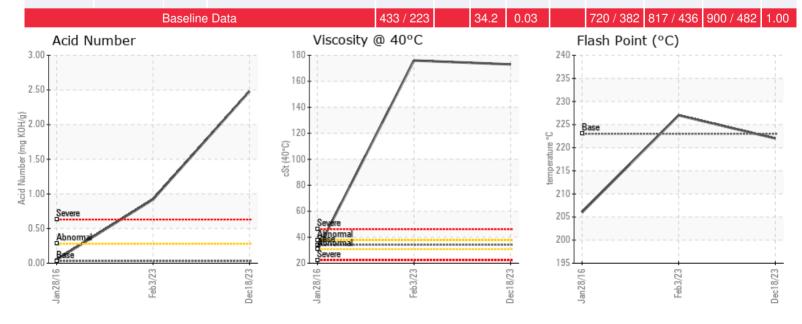
Sample Date	Received Date	Fluid Age	Sample Location	Flash Point (COC)	Water (KF)	Viscosity (40°C)	Acid Number	Solids	GCD 10%	GCD 50%	GCD 90%	GCD % < 335°C
	mm/dd/yy			°F/°C	ppm	cSt	mg/KOH/ g	%wt	°F/°C	°F/°C	°F/°C	%
12/18/23	01/05/24	7.0y		432 / 222	103	173	2.48	3.47	716 / 380	801 / 427	884 / 473	1.73
02/03/23	03/17/23	0.0y	sight glass	441 / 227	119.6	176	0.92	0.500	722 / 383	803 / 428	886 / 474	0.99
01/28/16	02/16/16	6.0y	RETURN LINE	403 / 206	65.9	29.9	0.05	0.149	715 / 379	820 / 438	933 / 501	2.37
