## [CNRL / 13-26-67-5W6] STABILIZER #2

Customer: PTRHTF20197	System Information	Sample Information
CNRL GOLD CREEK 13-26-67-05W6 GRANDE PRAIRIE, AB CA Attn: Joe Beamish Tel: (780)512-7015 E-Mail: joe.beamish@cnrl.com	System Volume: 15000 ltr Bulk Operating Temp: 428F / 220C Heating Source: Blanket: Fluid: PETRO CANADA PETRO-THERM Make: PETRO-TECH	Lab No: 02614844 Analyst: Clinton Buhler Sample Date: 01/31/24 Received Date: 02/09/24 Completed: 02/20/24 Clinton Buhler Clinton.Buhler@HFSinclair.com

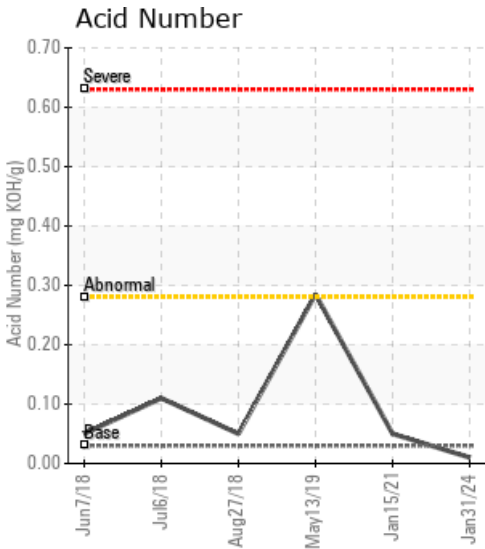
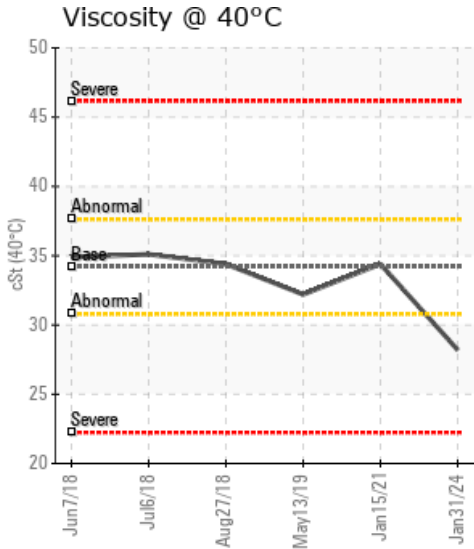
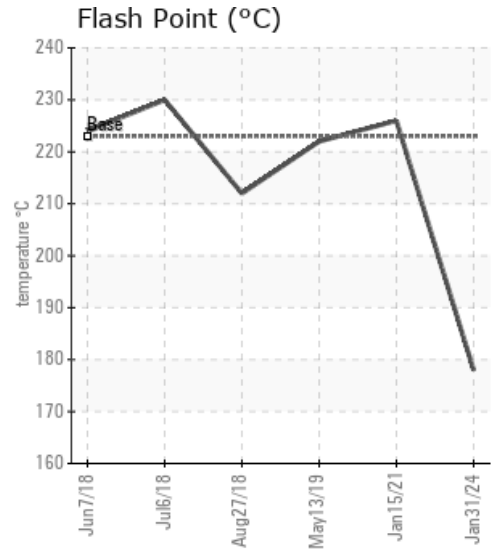
Sample Date	Received Date	Fluid Age	Sample Location	Flash Point (COC)	Water (KF)	Viscosity (40°C)	Acid Number	Solids	GCD 10%	GCD 50%	GCD 90%	GCD % < 335°C
	mm/dd/yy			°F/°C	ppm	cSt	mg/KOH/g	%wt	°F/°C	°F/°C	°F/°C	%
01/31/24	02/09/24	4.0y		352 / 178	105	28.2	0.01	0.044	713 / 378	812 / 433	910 / 488	3.45
01/15/21	01/28/21	15.0y	Heater Inlet	439 / 226	551.1	34.4	0.05	0.075	732 / 389	816 / 436	911 / 488	0.00
05/13/19	05/21/19	166.0y	150FT DOWNSTREAM	432 / 222	14959.5	32.2	0.285	0.303	719 / 382	813 / 434	930 / 499	0.88
08/27/18	08/30/18	1.0y	DISCHARGE OF PUMP	414 / 212	2156.2	34.4	0.05	0.492	727 / 386	816 / 435	919 / 493	0.00
07/06/18	07/10/18	3.0y	DISCHARGE CIRC PUMPS	446 / 230	2726.5	35.1	0.11	0.116	704 / 373	779 / 415	860 / 460	0.00
Baseline Data				433 / 223		34.2	0.03		720 / 382	817 / 436	900 / 482	1.00

Recommendation: Sample results indicate a reduced fluid viscosity which in turn has reduced the fluid's flash point (178C). Typical causes of this in heat transfer systems include too-high blanket gas pressure in the expansion tank, thermal degradation or contamination with lighter process fluids such as condensate. Please confirm if it is possible that process fluids may have mixed with the heat transfer fluid. To help restore fluid properties, it is recommended to perform regular venting of the expansion tank to reduce the low boiler vapor content (currently at 3.45%). After thorough venting and elimination of potential leaks, please re-sample in 3 months. Try to sample system from a hot, turbulent zone such as pump discharge.

Comments: COC Flash Point is abnormally low. Visc @ 40°C is abnormally low.

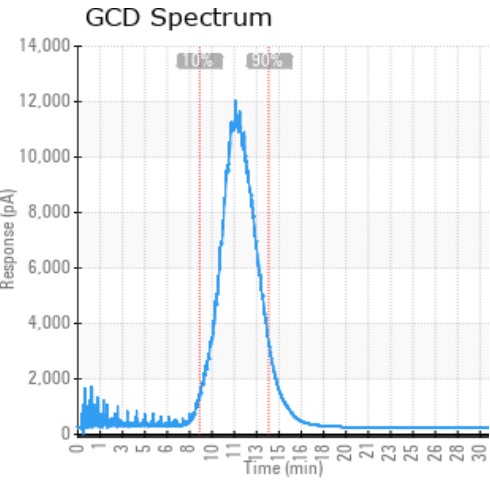
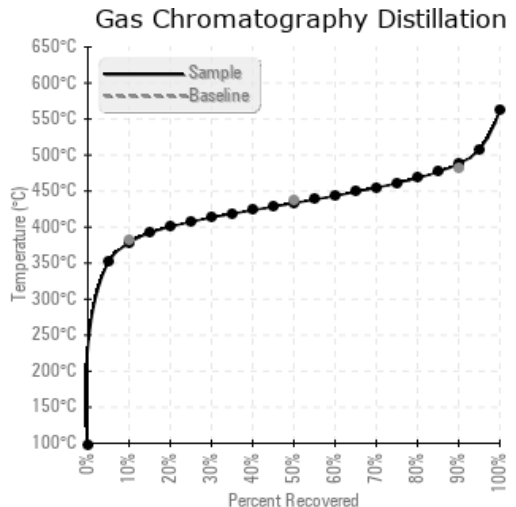
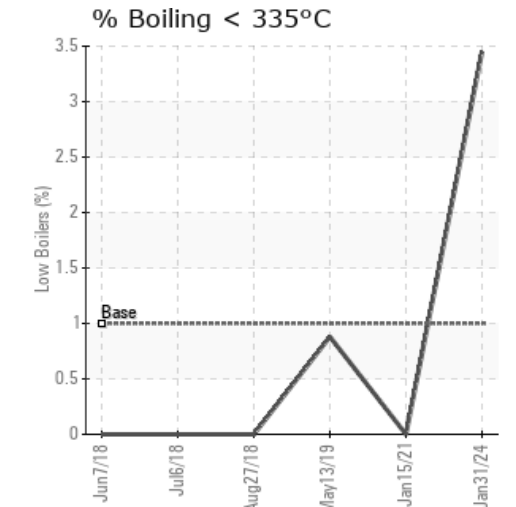
Sample Date	Iron	Chromium	Nickel	Aluminum	Copper	Lead	Tin	Cadmium	Silver	Vanadium	Silicon	Sodium	Potassium	Titanium	Molybdenum	Antimony	Manganese	Lithium	Boron	Magnesium	Calcium	Barium	Phosphorus	Zinc
01/31/24	0	0	0	0	0	0	0	0	0	0	0	0	0	0	0	0	0	0	0	0	0	0	0	0
01/15/21	0	0	0	0	0	0	0	0	0	0	0	4	0	0	0	0	0	0	1	0	0	0	0	0
05/13/19	0	0	0	0	0	0	0	0	0	0	0	25	1	0	0	0	0	0	0	0	2	0	0	0
08/27/18	6	0	0	0	0	0	0	0	0	0	0	19	2	0	0	0	0	0	0	1	5	0	2	0
07/06/18	0	0	0	0	0	0	0	0	0	0	0	3	0	0	0	0	0	0	0	0	0	0	0	0
Baseline Data			0	0						0			0	0				0					0

Elemental analysis results (above) in parts per million (ppm). [10,000 ppm = 1.0%]
