# **WANSON 600LNE**

# System Information

Fluid: PETRO CANADA PURITY FG HEAT TRANSFER FLUID

# Sample Information

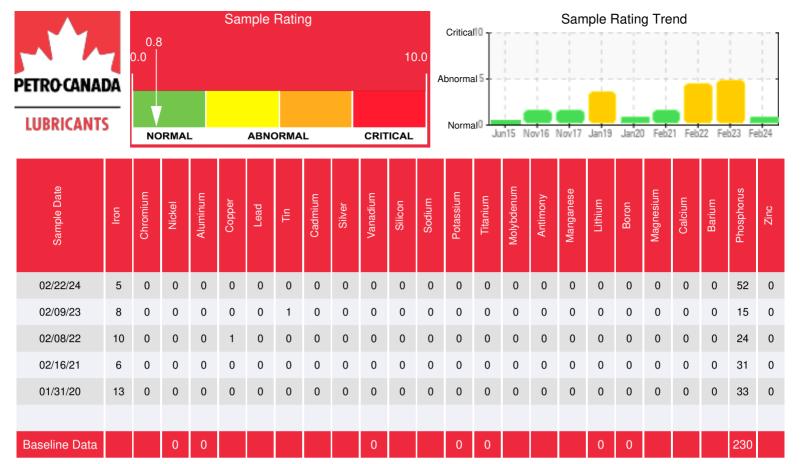
Elemental analysis results (above) in parts per million (ppm). [10,000 ppm = 1.0%]

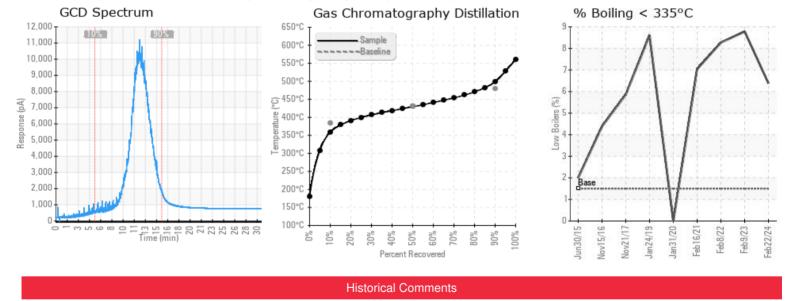
# safely. The GCD curve shows evidence of thermal cracking and the viscosity loss (although not critical) supports this is some way. Recommend system is vented and system temperatures are loaded into the oil analysis program. COC Flash Point is severely low. (GCD) % < 335°C is marginally high. (GCD) 10% Distillation Point is marginally low. All parameters within acceptable limits except for the COC Flash Point. Ne details on system temperature so please provide these. The fluid has been successfully recovered in recent months, recommend this is attempted by venting if it can be done safely. The GCD curve shows evidence of thermal cracking and the viscosity loss (although not critical) supports this is some way. Recommend system is vented and system temperatures are loaded into the oil analysis program. COC Flash Point is severely low. (GCD) % < 335°C is marginally high. (GCD) 10% Distillation Point is marginally low. All parameters within acceptable limits except for the COC Flash Point. Ne details on system temperature so please provide these. The fluid has been successfully recovered in recent months, recommend this is attempted by venting if it can be done safely. The GCD curve shows evidence of thermal cracking and the viscosity loss (although not critical) supports this is some way. Recommend system is vented and system temperatures are loaded into the oil analysis program. COC Flash Point is severely low. Fluid improved/recovered from previous analysis results. Please resample at normal frequency, oil fit for further use (GCD) 90% Distillation Point is abnormally

low. COC Flash Point is marginally low. (GCD) % < 335°C measurement of 0.00% too low, but will have been decreased as Flash Point has increased.
