# **KAONA FUTHER 4**

# System Information

Fluid: PETRO CANADA PURITY FG HEAT TRANSFER FLUID

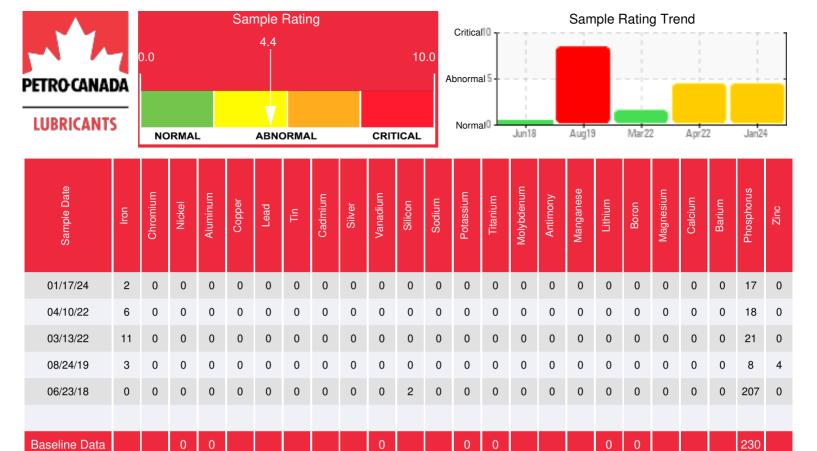
Elemental analysis results (above) in parts per million (ppm). [10,000 ppm = 1.0%]

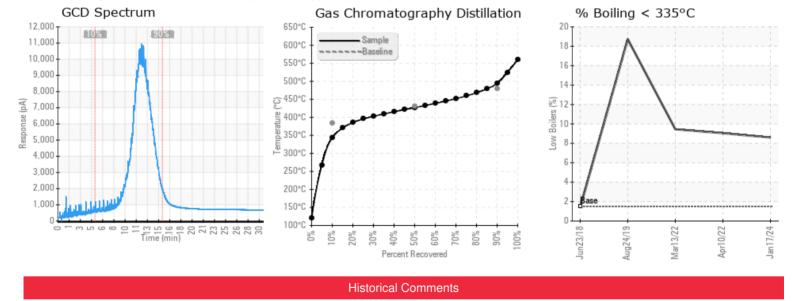
GCD analysis indicates light ends present in the fluid. Recommend venting the expansion tank to removal any volatiles present in the fluid to restore the flash point of the fluid. Resample at the next service interval to monitor. COC Flash Point is severely low. (GCD) 10% Distillation Point is abnormally low. (GCD) % < 335°C is marginally high. The condition of the fluid is acceptable for the time in service.

Has this oil been changed since the previous sample? If so, was there a clean and flush? The previous sample was worse in terms of flash point, evidence of cracking, GCD distillation points, low viscosity. However, the current situation the above mentioned physical characteristics remain off spec and of potential consequence. Please feedback what has happened with this fluid, if it was changed then the change probably had no clean and flush and there is carryover from previous fluid. If the fluid was vented to recover flash point for example, it has partially done this, but you need to look to change this fluid with a clean and flush COC Flash Point is severely low. (GCD) 10% Distillation Point is abnormally low. (GCD) % < 335°C is marginally high.

Sample rating very poor. Viscosity loss, flash point extremely low, evidence of fluid cracking on GC Distillation. Recommend a fluid change and resample following the change. Please inspect system and consider a clean and flush (GCD) % < 335°C is severely high. (GCD) 10% Distillation Point is severely low. COC Flash Point is severely low. (GCD) 90% Distillation Point is marginally high.

Comments: (GCD) 90% Distillation Point is abnormally high. (GCD) % < 335°C is marginally high. (GCD) 10% Distillation Point is marginally low. COC Flash Point is marginally low.
