[VESTA SYLVAN LAKE] 6-20-37-1-W5 HEAT MEDIUM #2

System Information

Fluid: PETRO CANADA PETRO-THERM

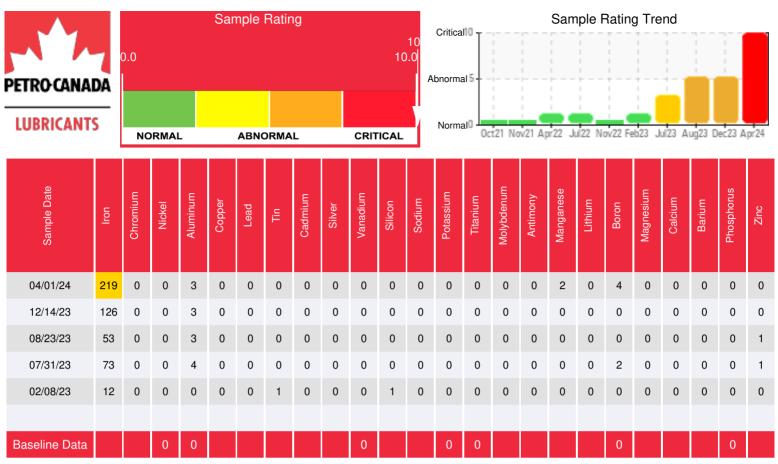
Elemental analysis results (above) in parts per million (ppm). [10,000 ppm = 1.0%]

Comments: PQ levels are severe. Iron ppm levels are abnormal. Solid Insolubles levels are severely high. Acid Number (AN) is severely high. Visc @ 40°C is abnormally high.
