## LINE 1/2

Customer: PTRHTF60002	System Information	Sample Information
BOYNE SMELTERS LTD-RIO TINTO HANDLEY DRIVE QUEENSLAND BOYNE ISLAND, QUE 4680 AU Attn: Heath Mitchell Tel: E-Mail: heath.mitchell@riotinto.com	System Volume: 20000 ltr Bulk Operating Temp: 514F / 268C Heating Source: Blanket: Fluid: PETRO CANADA CALFLO AF Make:	Lab No: 02628613 Analyst: Philip Riley Sample Date: 03/26/24 Received Date: 04/12/24 Completed: 04/30/24 Philip Riley philip.riley@HFSinclair.com

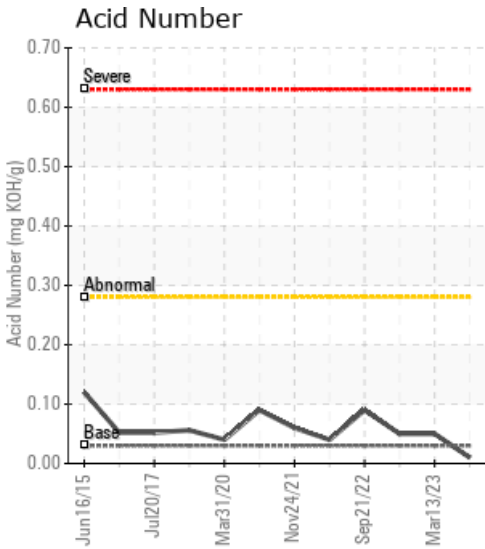
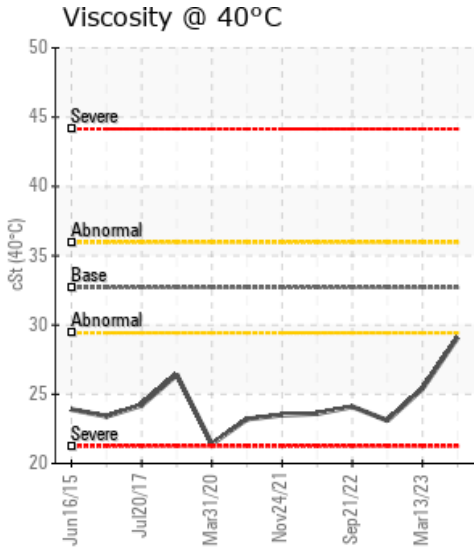
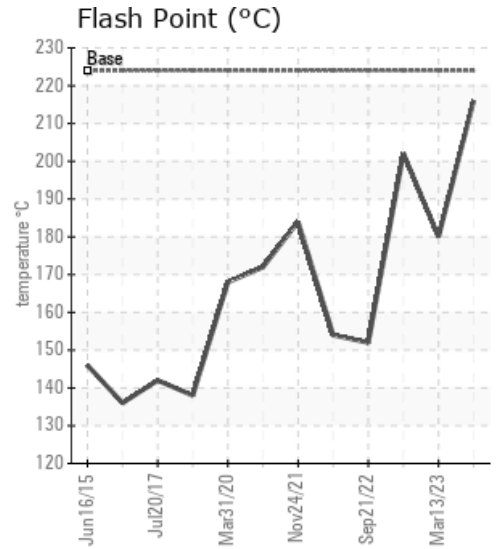
Sample Date	Received Date	Fluid Age	Sample Location	Flash Point (COC)	Water (KF)	Viscosity (40°C)	Acid Number	Solids	GCD 10%	GCD 50%	GCD 90%	GCD % < 335°C
	mm/dd/yy			°F/°C	ppm	cSt	mg/KOH/g	%wt	°F/°C	°F/°C	°F/°C	%
03/26/24	04/12/24	30.0y		421 / 216	11	29.1	0.01	0.059	670 / 354	777 / 414	889 / 476	5.24
03/13/23	06/02/23	30.0y	HEATER	356 / 180	33.7	25.4	0.05	0.067	671 / 355	792 / 422	895 / 480	5.94
01/19/23	02/14/23	20.0y	HTF Heater	396 / 202	12.0	23.1	0.05	0.937	690 / 366	799 / 426	902 / 484	4.21
09/21/22	10/04/22	30.0y		306 / 152	17.9	24.1	0.09	0.044	658 / 348	789 / 420	895 / 480	7.48
05/27/22	06/07/22	0.0y		309 / 154	15.5	23.6	0.04	0.067	662 / 350	789 / 420	893 / 479	6.89
Baseline Data				435 / 224		32.7	0.03		693 / 367	790 / 421	887 / 475	2.5

Recommendation: Viscosity at 40C is marginally low, represents no concern. Flash point, GCD, Insols all within the expected parameters and the oil is fit for further use. Please resample at normal frequency

Comments: Visc @ 40°C is abnormally low.
