### [D-39-D/94-H-3] H-4030

**System Information**  
 System Volume: 14000 ltr  
 Bulk Operating Temp: 518F / 270C  
 Heating Source:  
 Blanket:  
 Fluid: PETRO CANADA PETRO-THERM  
 Make: ALCO

**Sample Information**  
 Lab No: 02630815  
 Analyst: Clinton Buhler  
 Sample Date: 03/25/24  
 Received Date: 04/22/24  
 Completed: 04/25/24  
 Clinton Buhler  
 Clinton.Buhler@HFSinclair.com

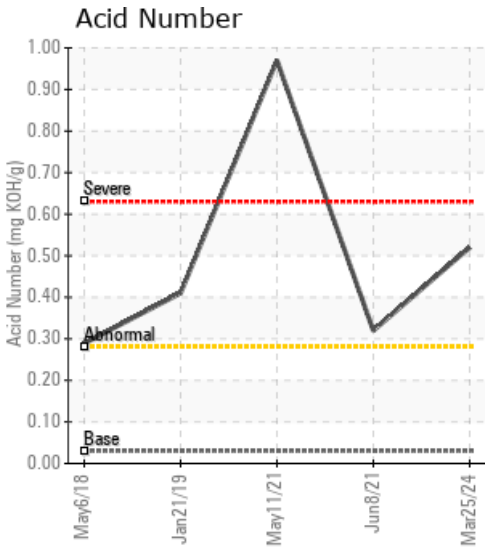
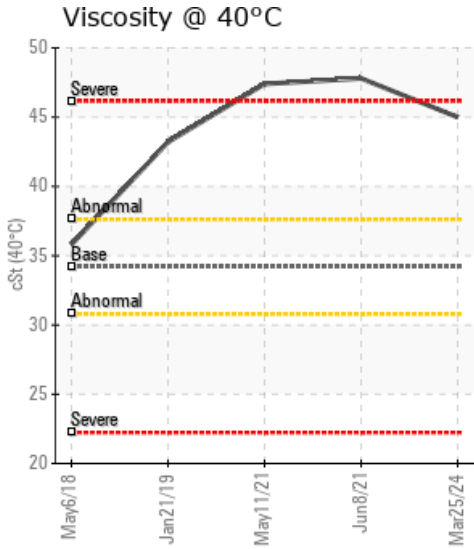
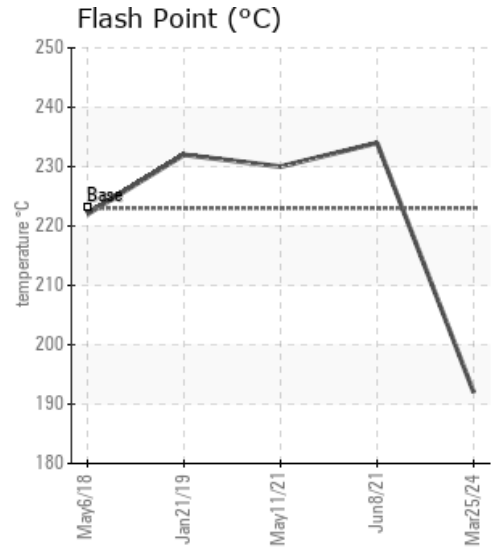
Sample Date	Received Date	Fluid Age	Sample Location	Flash Point (COC)	Water (KF)	Viscosity (40°C)	Acid Number	Solids	GCD 10%	GCD 50%	GCD 90%	GCD % < 335°C
	mm/dd/yy			°F/°C	ppm	cSt	mg/KOH/g	%wt	°F/°C	°F/°C	°F/°C	%
03/25/24	04/22/24	60.0m		378 / 192	52	45.0	0.52	1.69	685 / 363	810 / 432	917 / 492	5.67
06/08/21	06/14/21	0.0m	C/S REBOILER	453 / 234	319.9	47.8	0.32	0.932	700 / 371	798 / 426	908 / 486	3.49
05/11/21	05/26/21	5.0m	Reboiler	446 / 230	51.4	47.4	0.97	1.40	701 / 372	798 / 426	922 / 494	3.38
01/21/19	02/01/19	12.0m		450 / 232	157.0	43.2	0.410	0.241	706 / 375	792 / 422	892 / 478	0.36
05/06/18	07/10/18	18.0m		432 / 222	159.7	35.8	0.289	0.210	718 / 381	810 / 432	907 / 486	1.33
Baseline Data				433 / 223		34.2	0.03		720 / 382	817 / 436	900 / 482	1.00

Recommendation: Sample results indicate the fluid continues to degrade. Acid Number has increased from 0.32 to 0.52 and solids content (indicative of fouling) has nearly doubled, now at 1.69%. Flash point has gone down to 192C, which corresponds with increased low boiler vapor content now at 5.67%. These conditions suggest a combination of thermal and oxidative degradation. Care should be taken to plan fluid changeout and system cleaning in the future. Please make sure blanket gas remains operational. Re-sample within 6 months.

Comments: Pentane Insolubles levels are severely high. Acid Number (AN) is abnormally high. Visc @ 40°C is abnormally high. COC Flash Point is marginally low.
