# [16-11-54-15W5] TOURMALINE

Tourmaline 16-11-54-15W5

## System Information

### Sample Information

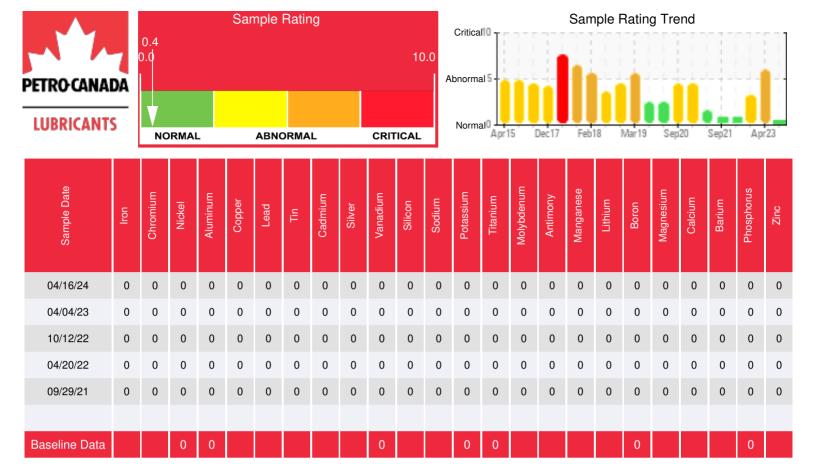
Elemental analysis results (above) in parts per million (ppm). [10,000 ppm = 1.0%]
