[C-39-D/94-H-3] H-6300

Customer: PTRHTF60077
 Canadian Natural Resources (CNRL)
 C-39-D/94-H-3
 Fort St. John, BC V1J 4H9 CA
 Attn: Jesse Dyer
 Tel: (250)262-1778
 E-Mail: jesse.dyer@cnrl.com

System Information
 System Volume: 14000 ltr
 Bulk Operating Temp: 518F / 270C
 Heating Source:
 Blanket:
 Fluid: PETRO CANADA PETRO-THERM
 Make: ALCO

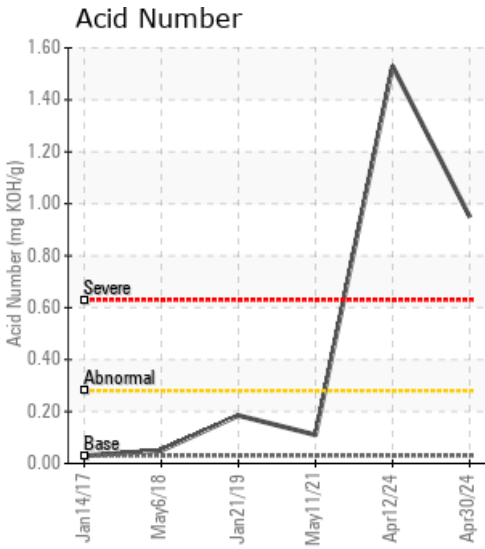
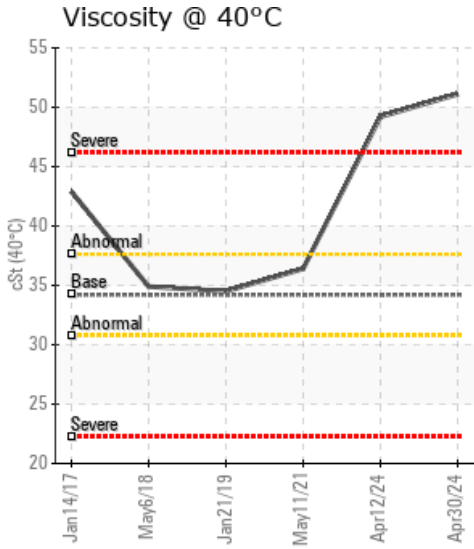
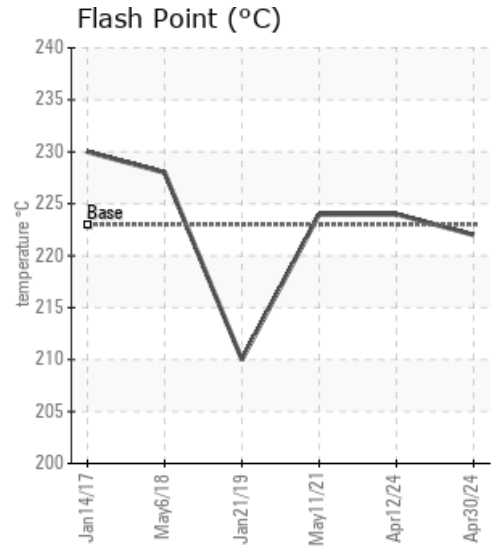
Comments: PQ levels are severe. Iron ppm levels are abnormal. Pentane Insolubles levels are severely high. Acid Number (AN) is severely high. Visc @ 40°C is severely high. (GCD) 90% Distillation Point is marginally high.

Historical Comments	
04/12/24	Sample results indicate that the fluid is severely degraded and that system fouling is ongoing. Oxidation appears to be the primary form of degradation based on the Acid Number of 1.53 (condemnable at 1) and the increased fluid viscosity corresponds with this. Iron content has increased dramatically to 428 ppm which likely is associated with system corrosion. Solids content has jumped to 0.969% which is likely due to degradation based deposits but the iron content in the fluid also contributes to this. System requires fluid replacement preceded by a system clean and flush. Please contact Lance Guest (account manager) and Clinton Buhler (tech services) to discuss the use of Calflo Cleaning and Calflo Flushing fluid to restore the system cleanliness. Considering how severe the fluid condition appears, it is advise to re-sample to confirm, but to make sure the sample is taken from a turbulent zone (pump discharge). If this sample was taken from a turbulent area, and not a dead leg, it should be representative. Iron ppm levels are severe. PQ levels are severe. Pentane Insolubles levels are severely high. Acid Number (AN) is severely high. Visc @ 40°C is severely high. (GCD) 90% Distillation Point is abnormally high.
