## **CONSTRUCTION EQUIPMENT**

### LIEBHERR CANADA LTD. - REMAN

Depot: REMAN Unique No: 5605248 Kevin Marson Signed: Report Date: 07 Jul 2023

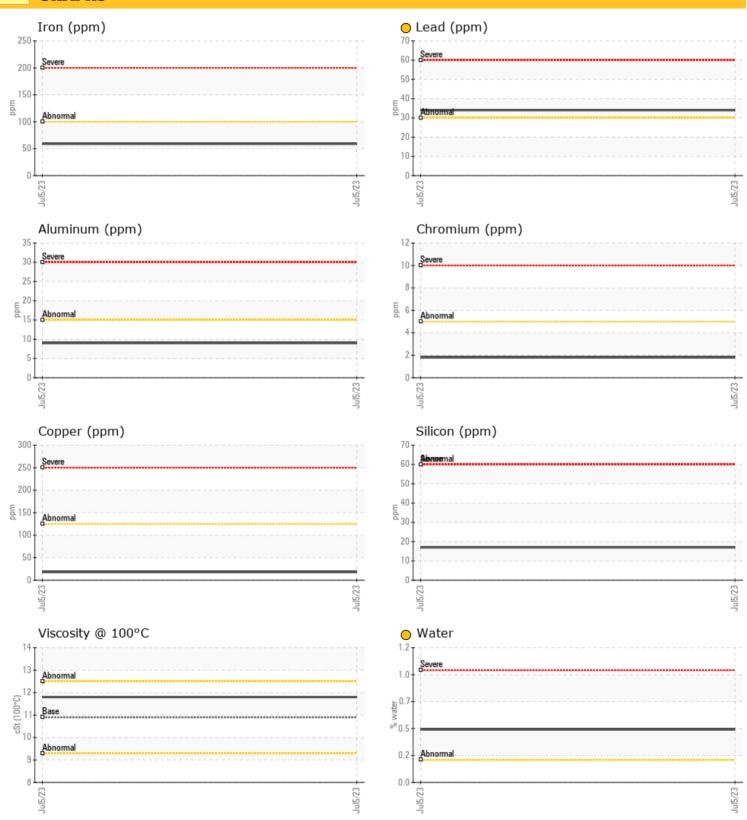
## **GRAPHS**

CONTAMINATION					
Water	%	<b>0.471</b>			
Soot %	%	<b>0.2</b>			
Nitration (PA)	%	116			
Sulfation (PA)	%	87			
Glycol	%	<b>0.0</b>			
Fuel	%	<b>1.5</b>			
Silicon	ppm	<b>17</b>			
Sodium	ppm	<b>4</b>			
Potassium	ppm	<b>8</b>

WEA	R METAL	S		
Iron	ppm	<b>59</b>	 	
Copper	ppm	<b>18</b>	 	
Lead	ppm	<b>34</b>	 	
Tin	ppm	<b>17</b>	 	
Aluminum	ppm	<b>9</b>	 	
Chromium	ppm	<b>2</b>	 	
Molybdenum	ppm	<b>20</b>	 	
Nickel	ppm	<b>0</b> <1	 	
Titanium	ppm	<b>29</b>	 	
Silver	ppm	<b>○</b> <1	 	
Manganese	ppm	<b>1</b>	 	
Vanadium	ppm	<1

variaulum	ppiii	<u> </u>	 	
ADI	DITIVES			
Calcium	ppm	<b>1581</b>	 	
Magnesium	ppm	<b>999</b>	 	
Zinc	ppm	<b>1306</b>	 	
Phosphorus	ppm	<b>1128</b>	 	
Barium	ppm	<b>0</b>	 	
Boron	ppm	<b>72</b>

We advise that you check for the source of water entry. We advise that you monitor for an abnormal oil pressure drop and noise. We recommend that you drain the oil from the component if this has not already been done. We recommend an early resample to monitor this condition. Tin ppm levels are severe. Lead ppm levels are abnormal. Bearing wear is indicated. Slide bearing wear is indicated. Light fuel dilution occurring. There is a moderate concentration of water present in the oil. Test for glycol is negative. No other contaminants were detected in the oil. The oil is no longer serviceable as a result of the abnormal and/or severe wear.
