PROBLEM SUMMARY

Area
[97853728]
 Machine Id
KR-GR-002930 - GRINDER A1 (EAST) (S/N GRIND A - 11513021)
 Component
Gearbox
 Fluid
GEAR OIL ISO 220 (6 QTS)

OIL ANALYSIS REPORT

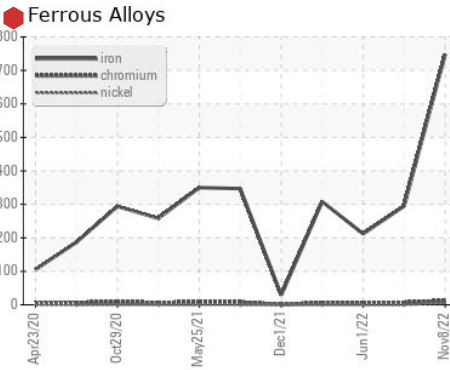
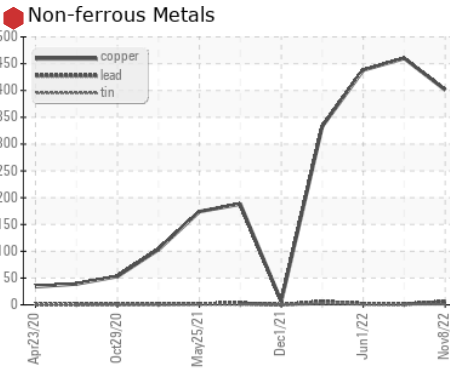
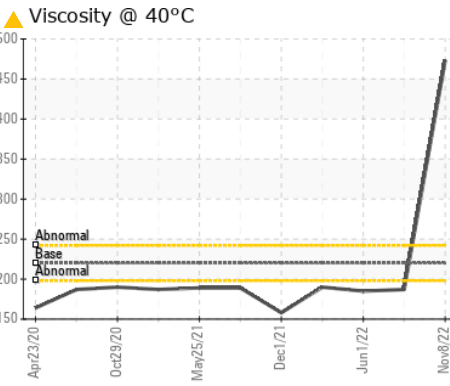
GRAPHS

method	limit/base	current	history1	history2	
Iron	ppm	ASTM D5185m >200	747	295	212
Chromium	ppm	ASTM D5185m >15	13	7	6
Nickel	ppm	ASTM D5185m >15	4	0	0
Titanium	ppm	ASTM D5185m	<1	<1	<1
Silver	ppm	ASTM D5185m	0	0	2
Aluminum	ppm	ASTM D5185m >25	15	13	11
Lead	ppm	ASTM D5185m >100	6	1	2
Copper	ppm	ASTM D5185m >200	401	460	438
Tin	ppm	ASTM D5185m >25	1	1	1
Vanadium	ppm	ASTM D5185m	<1	0	0
Cadmium	ppm	ASTM D5185m	0	0	0

method	limit/base	current	history1	history2	
Silicon	ppm	ASTM D5185m >50	66	81	80
Sodium	ppm	ASTM D5185m	2	0	0
Potassium	ppm	ASTM D5185m >20	1	0	0
Water	%	ASTM D6304 >0.2	26.0	0.473	0.219
ppm Water	ppm	ASTM D6304 >2000	260000	4730	2190

FLUID PROPERTIES		method	limit/base	current	history1	history2
Visc @ 40°C	cSt	ASTM D445	220	▲ 473.3	187	185

Contamination
 Appearance is milky. Free water present. There is a high concentration of water present in the oil. Elemental levels of silicon (Si) and aluminum (Al) indicate alumina-silicate (coarse dirt) ingress.

Fluid Condition
 Viscosity of sample indicates oil is within ISO 460 range, advise investigate. Confirm oil type. The oil is no longer serviceable due to the presence of contaminants.
