# CONSTRUCTION EQUIPMENT

371606 VOLVO A40G 342484 - COOLANT

## SAMPLE INFORMATION

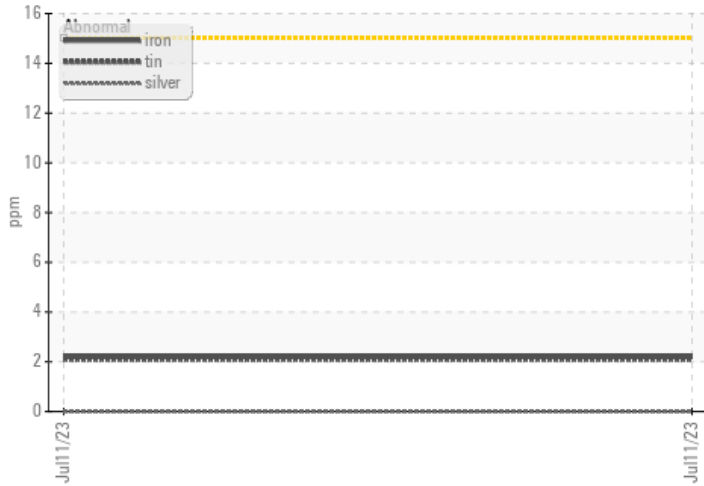
### Iron/Tin/Silver

Iron	ppm	2	---	---	---
Aluminum	ppm	0	---	---	---
Copper	ppm	3	---	---	---
Lead	ppm	6	---	---	---
Tin	ppm	2	---	---	---
