580533 CITRUS VOLVO L110H 632401 - TRANSMISSION (AUTO)

Sample No: VCP393521
Oil Type: VOLVO AT 102
Job No: 580533 CITRUS

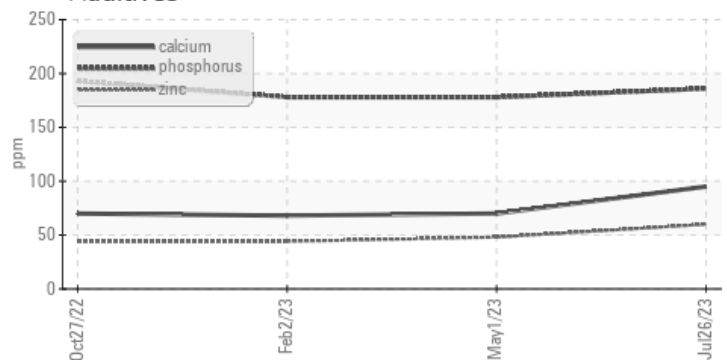
Additives

Calcium	ppm	95	70	68	70
Magnesium	ppm	1	1	<1	1
Zinc	ppm	60	48	44	44
Phosphorus	ppm	186	178	178	193
Barium	ppm	5	4	3	2
Boron	ppm	64	57	61	62
