# CONSTRUCTION EQUIPMENT

## 366720 VOLVO EC220EL 314927 - REAR LEFT FINAL DRIVE

**Sample No:** VCP433419  
**Oil Type:** VOLVO  
**Job No:** 366720

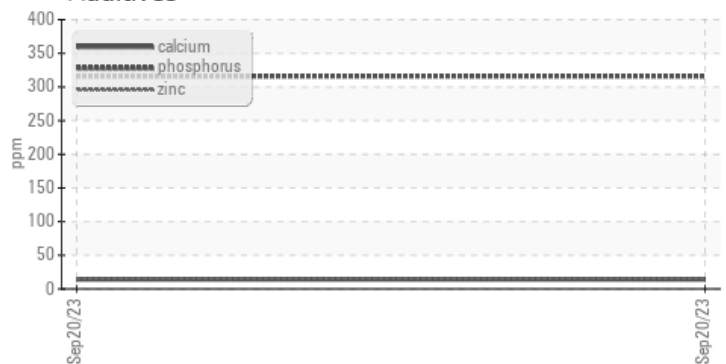
### Additives

Calcium	ppm	14	---	---	---
Magnesium	ppm	6	---	---	---
Zinc	ppm	15	---	---	---
Phosphorus	ppm	316	---	---	---
Barium	ppm	0	---	---	---
Boron	ppm	3	---	---	---
