# CONSTRUCTION EQUIPMENT

A12475 VOLVO L120G 30297 - COOLANT

**Sample No:** VCP446457  
**Oil Type:** EXTENDED LIFE COOLANT  
**Job No:** A12475

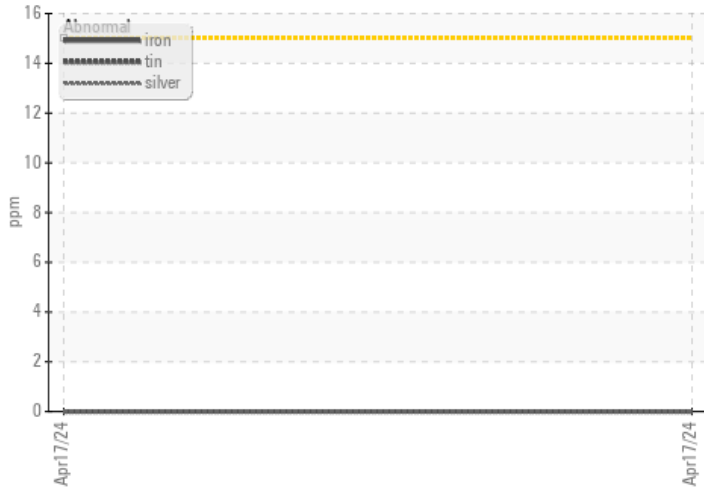
### Iron/Tin/Silver

Iron	ppm	0	---	---	---
Aluminum	ppm	0	---	---	---
Copper	ppm	0	---	---	---
Lead	ppm	0	---	---	---
Tin	ppm	0	---	---	---
