CONSTRUCTION EQUIPMENT

VOLVO L90H 625046 - TRANSMISSION (AUTO)

Sample No: VCP428797
Oil Type: VOLVO AT 102
Job No:

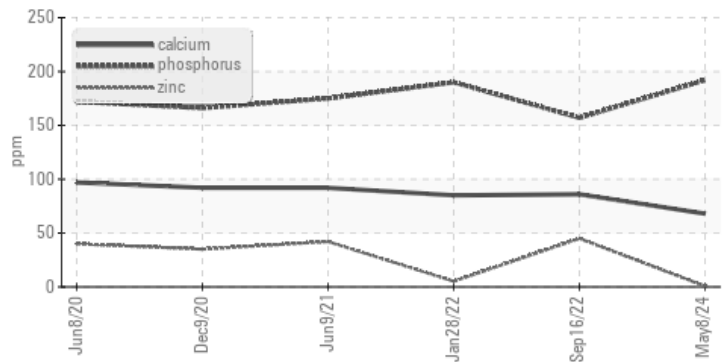
Additives

Calcium	ppm	68	86	85	92
Magnesium	ppm	<1	0	0	1
Zinc	ppm	<1	45	5	42
Phosphorus	ppm	192	157	190	175
Barium	ppm	0	0	0	0
Boron	ppm	85	33	69	50
