Machine Id

#### BAUER 1 Component Hydraulic System Fluid AW HYDRAULIC OIL ISO 150 (20 GAL)

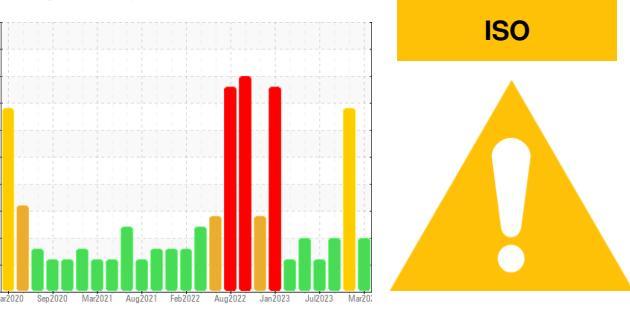
Sample Rating Trend

All component wear rates are normal.

There is a high amount of particulates present in the oil.

We recommend you service the filters on this component if applicable. Resample at the next service interval to monitor.

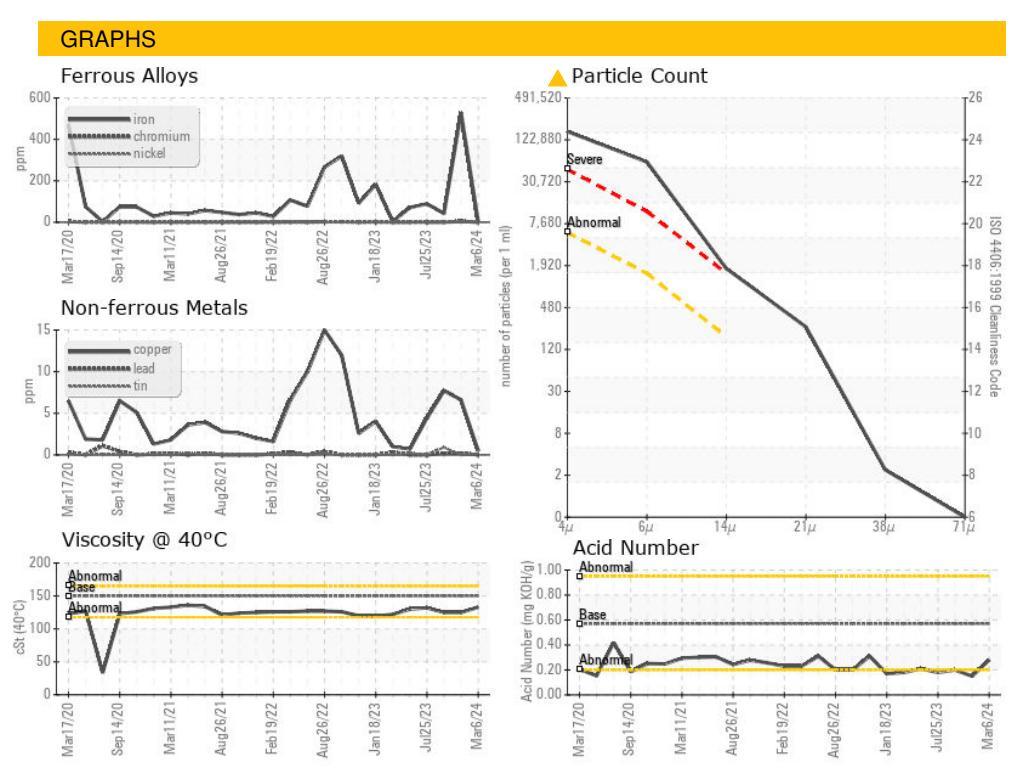
Bottom

VISUAL		method	limit/base	current	history1	history2
White Metal	scalar	*Visual	NONE	NONE	NONE	NONE
Yellow Metal	scalar	*Visual	NONE	NONE	NONE	NONE
Precipitate	scalar	*Visual	NONE	NONE	NONE	NONE
Silt	scalar	*Visual	NONE	NONE	A MODER	NONE
Debris	scalar	*Visual	NONE	LIGHT	NONE	NONE
Sand/Dirt	scalar	*Visual	NONE	NONE	NONE	NONE
Appearance	scalar	*Visual	NORML	NORML	NORML	NORML
Odor	scalar	*Visual	NORML	NORML	NORML	NORML
Emulsified Water	scalar	*Visual	>0.05	NEG	NEG	NEG
Free Water	scalar	*Visual		NEG	NEG	NEG
FLUID PROPERTIES		method	limit/base	current	history1	history2
Visc @ 40°C	cSt	ASTM D445	150	133	125	125
SAMPLE IMAGES		method	limit/base	current	history1	history2
Color
