Machine Id

## 930 HORTOP PUMP #4 Component Diesel Engine

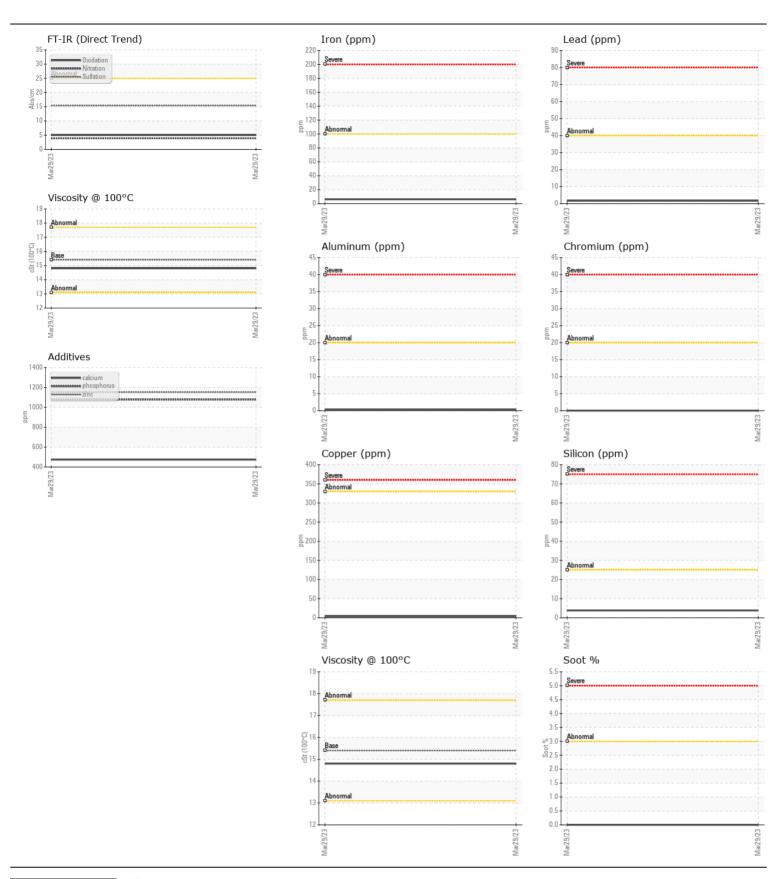
There is no indication of any contamination in the oil.	Potassium	ppm	ASTM D5185(m)		0		
	Fuel		WC Method		<1.0		
	Water		WC Method	>0.2	NEG		
	Glycol		WC Method		NEG		
	Soot %	%	ASTM D7844*		0		
	Nitration	Abs/cm	ASTM D7624*	>20	3.9		
	Sulfation	Abs/.1mm	ASTM D7415*	>30	15.4		
	Emulsified Water	scalar	Visual*	>0.2	NEG		
LUID CONDITION	Sodium	ppm	ASTM D5185(m)		<1		
Additive levels indicate the addition of a different brand, or type of oil. The condition of the oil is acceptable for the time in service.	Boron	ppm	ASTM D5185(m)	1	12		
	Barium	ppm	ASTM D5185(m)	1	0		
	Molybdenum	ppm	ASTM D5185(m)	1	4		
	Manganese	ppm	ASTM D5185(m)		0		
	Magnesium	ppm	ASTM D5185(m)	10	1202		
	Calcium	ppm	ASTM D5185(m)	3032	474		
	Phosphorus	ppm	ASTM D5185(m)	1054	1078		
	Zinc	ppm	ASTM D5185(m)	1332	1152		
	Sulfur	ppm	ASTM D5185(m)	3985	8897		
	Oxidation	Abs/.1mm	ASTM D7414*	>25	5.0		
	Visc @ 100°C	cSt	ASTM D7279(m)	15.4	14.8

RECOMMENDATION	Test	UOM	Method	Limit/Abn	Current	History1	History2
Confirm the source of the lubricant being utilized for top-up/fill.  Resample at the next service interval to monitor. Please specify the component make and model with your next sample.	Sample Number		Client Info		wc		
	Sample Date		Client Info		29 Mar 2023		
	Machine Age	yrs	Client Info		0		
	Oil Age	yrs	Client Info		0		
	Filter Age	yrs	Client Info		0		
	Oil Changed		Client Info		N/A		
	Filter Changed		Client Info		N/A		
	Sample Status				NORMAL		
VEAR	Iron	nnm	ASTM D5185(m)	>100	6		
All component wear rates are normal.	Chromium	ppm	ASTM D5185(III) ASTM D5185(m)		0		
	Nickel	ppm	ASTM D5185(m)		0		
	Titanium	ppm	ASTM D5185(m)	7	1		
	Silver	ppm	ASTM D5185(m)	>3	0		
	Aluminum	ppm	ASTM D5185(m)		<1		
	Lead	ppm	ASTM D5185(m)		2		
	Copper	ppm	ASTM D5185(m)		4		
	Tin	ppm	ASTM D5185(m)		<1		
	Vanadium	ppm	ASTM D5185(m)		0		
CONTAMINATION	Silicon	ppm	ASTM D5185(m)		4
