OIL ANALYSIS REPORT

Area
ENGINE ROOM 3RD DECK
 Machine Id
77-G-6582 ESSENTIAL SERVICES GENERATOR (S/N Maint Plan 22480)

Component
Diesel Engine
 Fluid
MOBIL MOBILGARD 412 (1300 LTR)

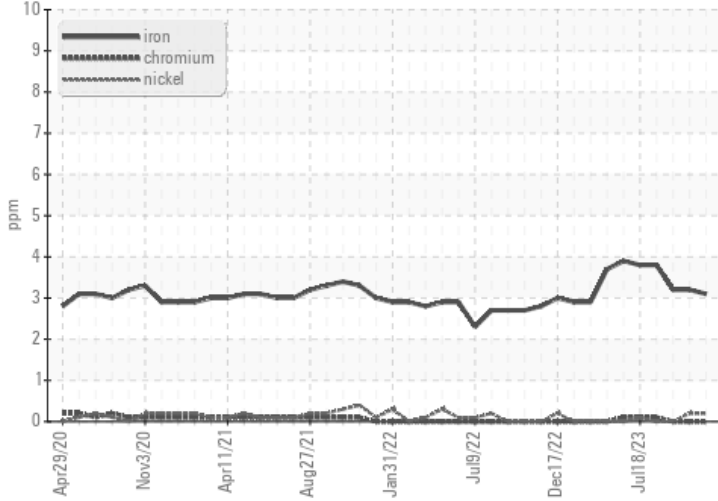
Ferrous Alloys

All component wear rates are normal. The ferrography results are normal indicating no abnormal wear in the system.

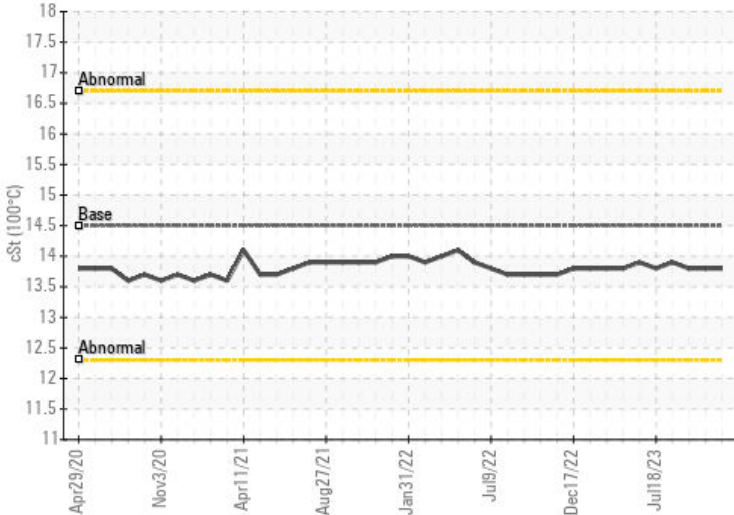
Viscosity @ 100°C

The BN result indicates that there is suitable alkalinity remaining in the oil. The condition of the oil is suitable for further service.
