WEAR CONTAMINATION FLUID CONDITION

Machine Id

14 ROYAL AVE NOBLETON YORK REGION 46857451

Rear Diesel Engine

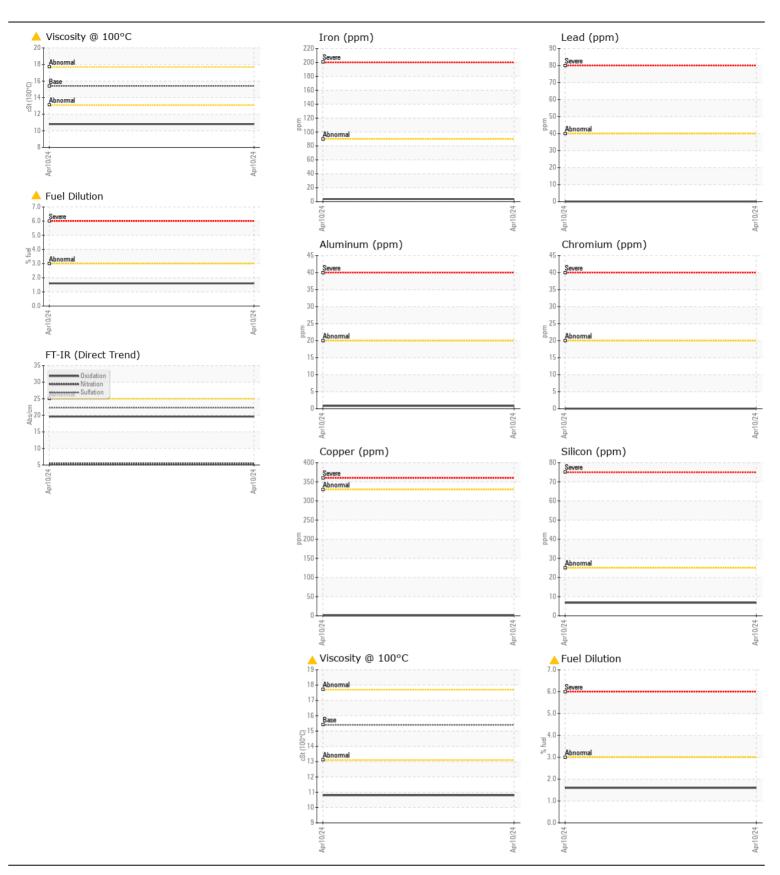
| RECOMMENDATION | Test | UOM | Method | Limit/Abn | Current | History1 | History2 |
|---|---|---|---|---|---|---|---|
| Metal levels are typical for a new component breaking in. | Nickel | ppm | ASTM D5185(m) | | 0 | | |
| Light fuel dilution occurring. | Potassium | ppm | ASTM D5185(m) | >20 | <1 | | |
| Fuel is present in the oil and is lowering the viscosity. The condition of the oil is acceptable for the time in service. | Sodium | ppm | ASTM D5185(m) | >192 | 3 | | |

| RECOMMENDATION | Test | UOM | Method | Limit/Abn | Current | History1 | History2 |
|---|---|---|---|---|---|---|---|
| The oil change at the time of sampling has been noted. Resample at the next service interval to monitor. | Sample Date | | Client Info | | 10 Apr 2024 | | |
