OIL ANALYSIS REPORT

Area
SAB1
Machine Id
Component
SAB1 G1 Governor
Hydraulic System
Fluid
ESSEO TERESSO ISO 46 (1600 LTR)

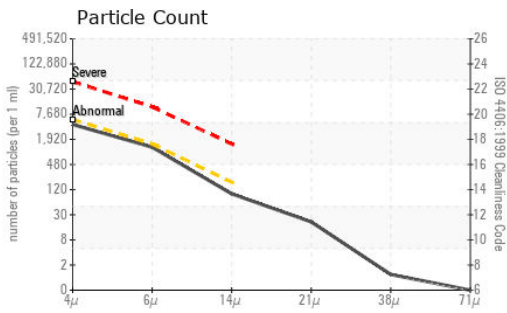
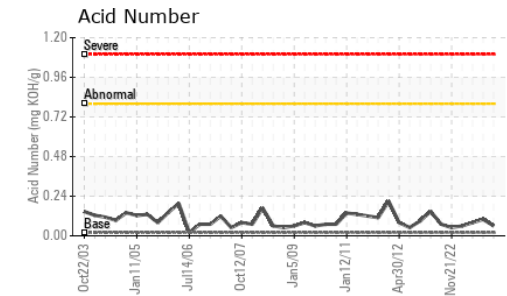
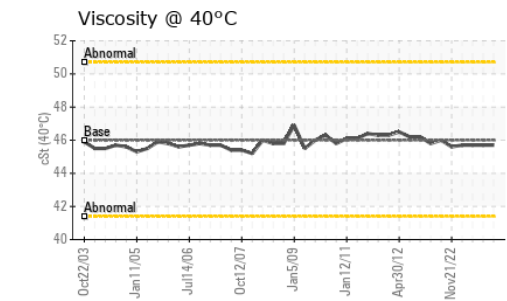
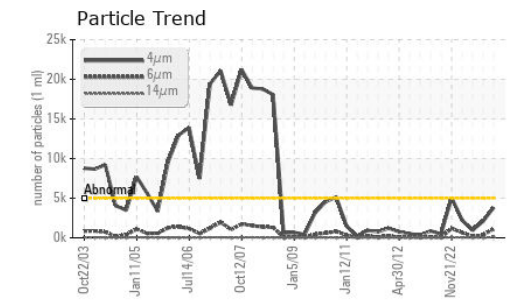
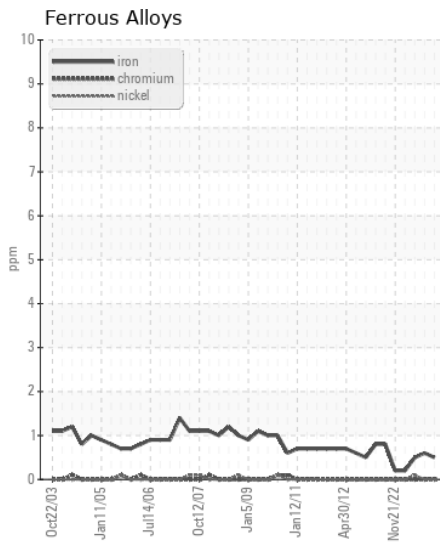
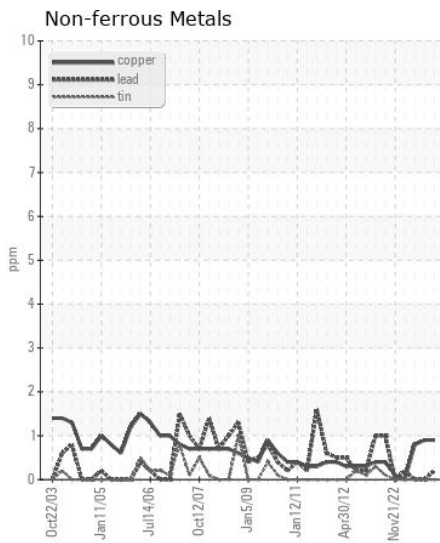
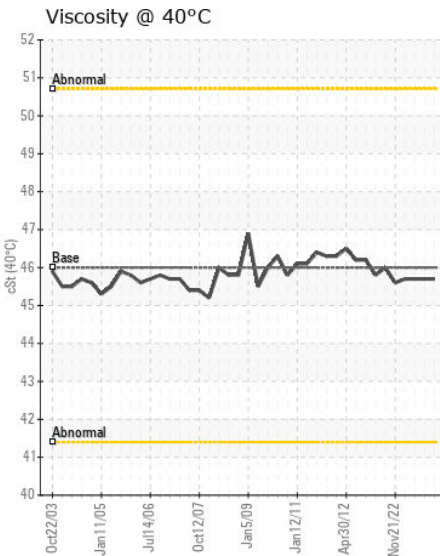
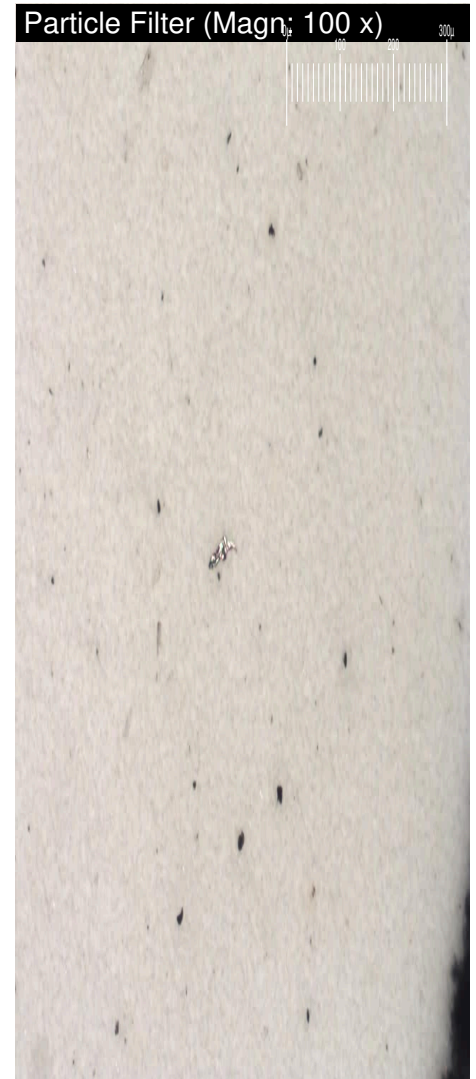
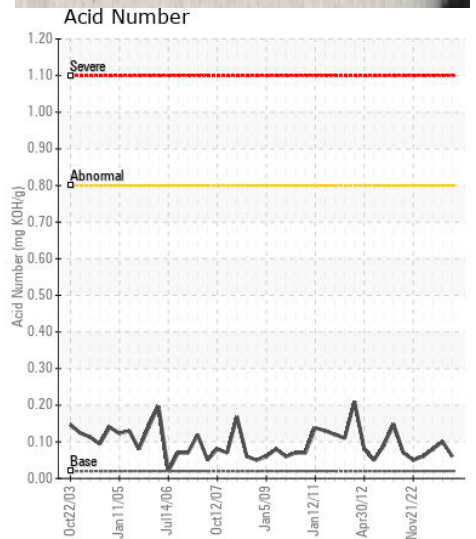
Light concentration of visible metal present.

The system cleanliness is acceptable for your target ISO 4406 cleanliness code. The system and fluid cleanliness is acceptable. NOTE: An increase in the particle count is noted.

We advise that you check for visible metal particles in the oil. We recommend an early resample to monitor this condition. Please contact your representative for information regarding the proper sampling kits for your service. NOTE: We recommend using IND 3 test kits, this testkit includes Analytical Ferrography which provides a detailed morphological analysis of wear particles present in the fluid.
