WEAR	<b>NORMAL</b>
CONTAMINATION	<b>NORMAL</b>
FLUID CONDITION	<b>NORMAL</b>

Area  
**DANIEL T MARTIN**  
Machine Id  
**[DANIEL T MARTIN] 001 608537-1**  
Component  
**Port Main Engine**  
Fluid  
**CHEVRON DELO 710 LE (250 GAL)**

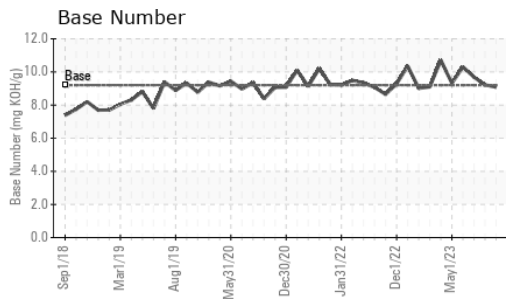
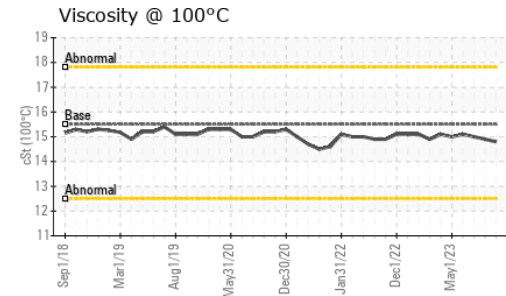
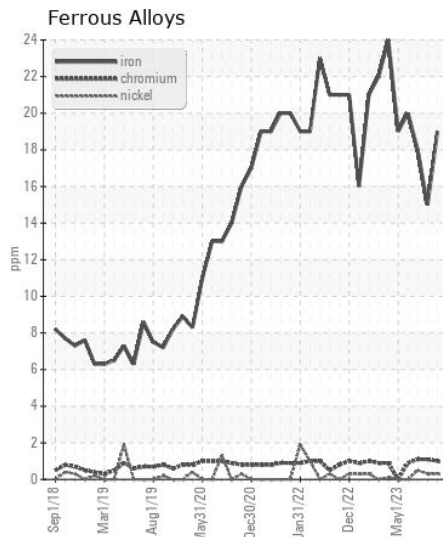
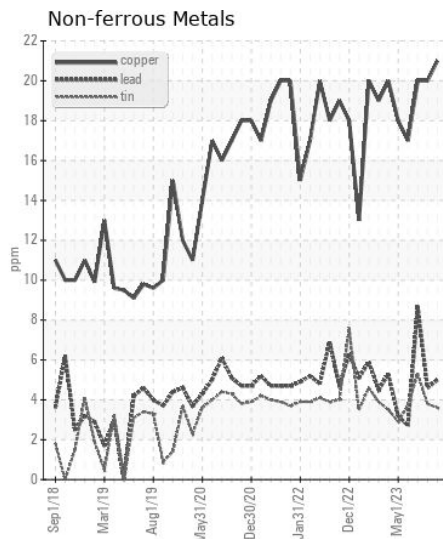
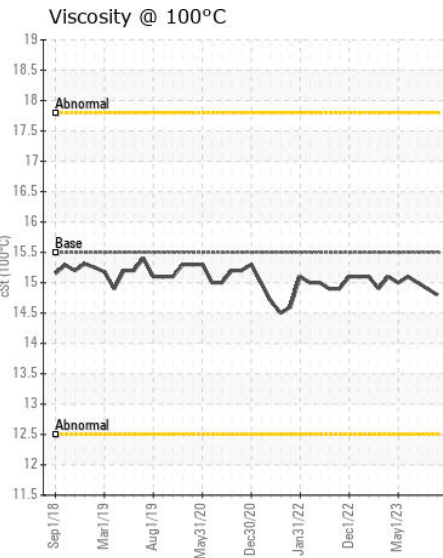
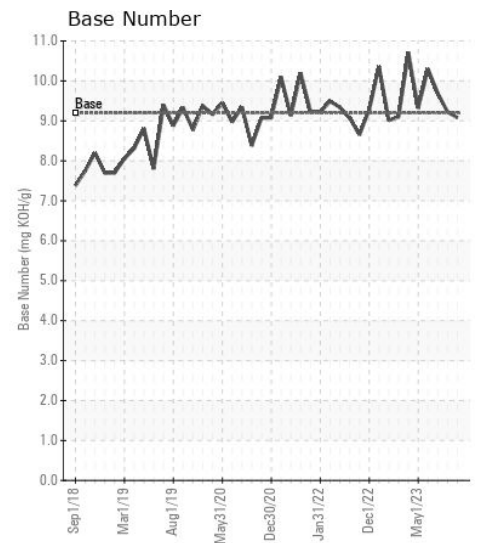
All component wear rates are normal.

Elevated aluminum (Al) and/or lead (Pb) and potassium (K) levels in your metals analysis are likely a result of solder flux release into the lubricant and is common on new equipment/components. There is no indication of any contamination in the oil.

The BN result indicates that there is suitable alkalinity remaining in the oil. The condition of the oil is suitable for further service.

Resample at the next service interval to monitor.
