FUEL REPORT

Machine Id
KIOTI YFF100350
 Component
Diesel Fuel
 Fluid
ON-ROAD (--- GAL)

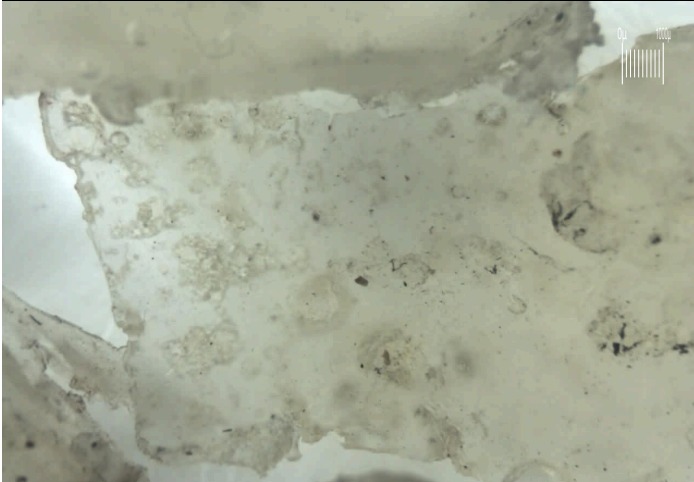
Magn: 10x Illum: RW

Diagnostician's Note: We were unable to clean and filter the filter element. The gel has hardened and cured. The material does not dissolve in Toluene, IPA, and heptane. The gel does not melt but burns. Filter has strong sweet smell. Suspect that this may be cured industrial spray adhesive or plastic film not removed before filter was installed. We were unable to load the gel into FTIR pearl to do an infra-red scan. All tests and evaluation performed at WearCheck Canada.
