G.LOPES CONSTRUCTION INC./Off-Road

L336 Component Coolant

EXTENDED LIFE COOLANT (--- GAL)

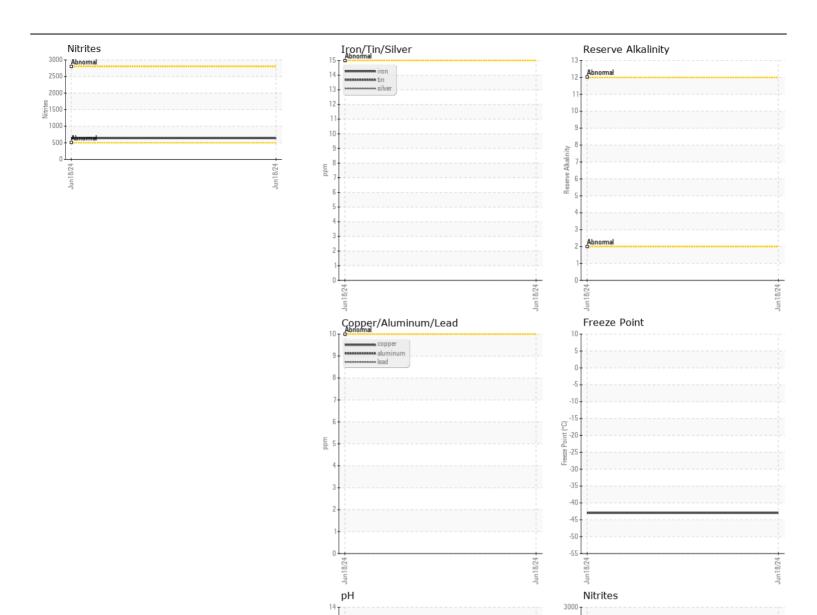
·····						
RECOMMENDATION	Test	UOM	Method	Limit/Abn	Current	History1	History2
The fluid is suitable for further service.	Sample Number		Client Info		PCA0122480		
	Sample Date		Client Info		18 Jun 2024		
	Machine Age	hrs	Client Info		9919		
	Oil Age	hrs	Client Info		9919		
	Oil Changed		Client Info		N/A		
	Sample Status				NORMAL		
CORROSION	Tatal Dissalard Oalida				400 =		
CORROSION	Total Dissolved Solids				493.5		
	Coolant Appearance		*Visual	Clear	normal		
CONTAMINANTS	Boiling Point	°C	WC Method		226		
There is no indication of any contamination in the coolant.	Specific Gravity		*ASTM D1298		1.072		
There is no indication of any contamination in the coolant.					1.072		
	рН	Scale 0-14	ASTM D1287		7.00		
	Nitrites	ppm	AP-053:2009		636		
	Reserve Alkalinity	Scale 0-20	*ASTM D1121				
	Percentage Glycol	%	ASTM D3321		53.5		
	Freezing Point	°F	ASTM D3321		-43		
	Carboxylate				n/a		
	Coolant Color		*Visual		Red
