WEAR	<b>NORMAL</b>
CONTAMINATION	<b>NORMAL</b>
FLUID CONDITION	<b>NORMAL</b>

Machine Id  
**SDA**  
Component  
**Steering**  
Fluid  
**CHEVRON HYDRAULIC AW ISO 68 (150 GAL)**

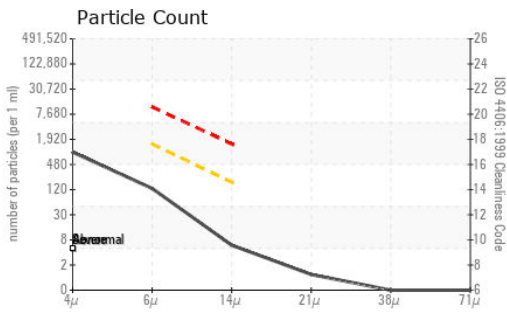
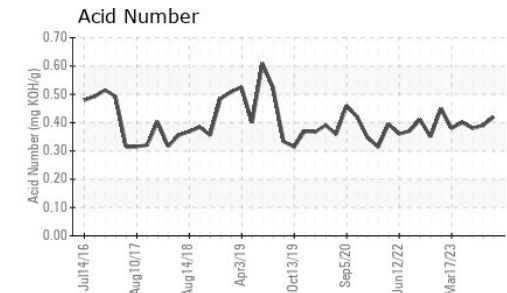
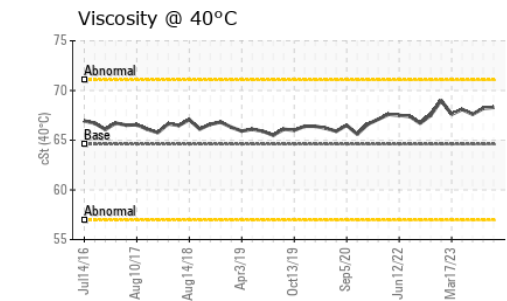
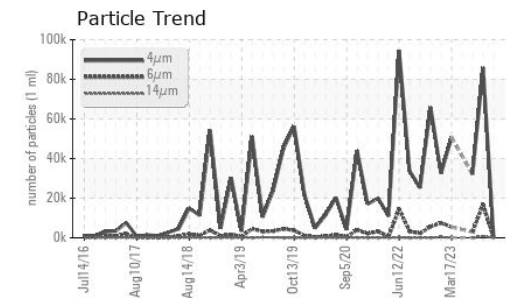
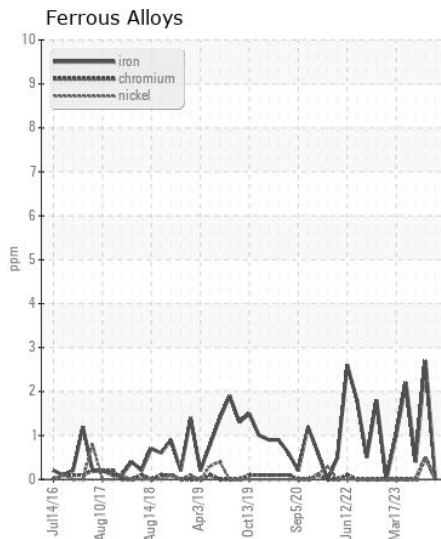
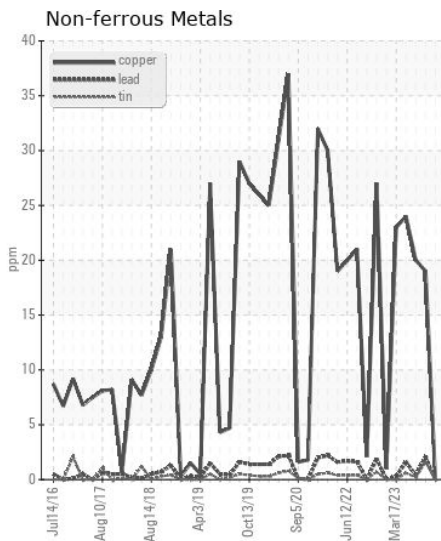
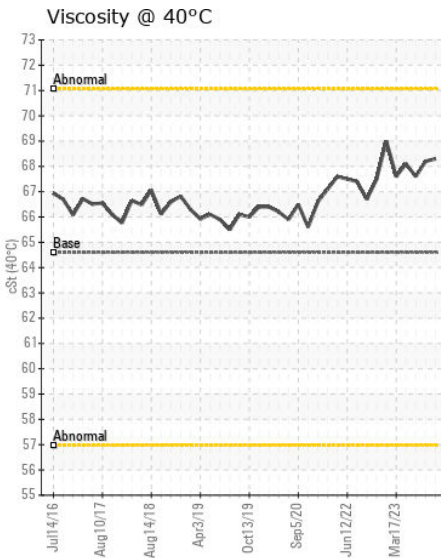
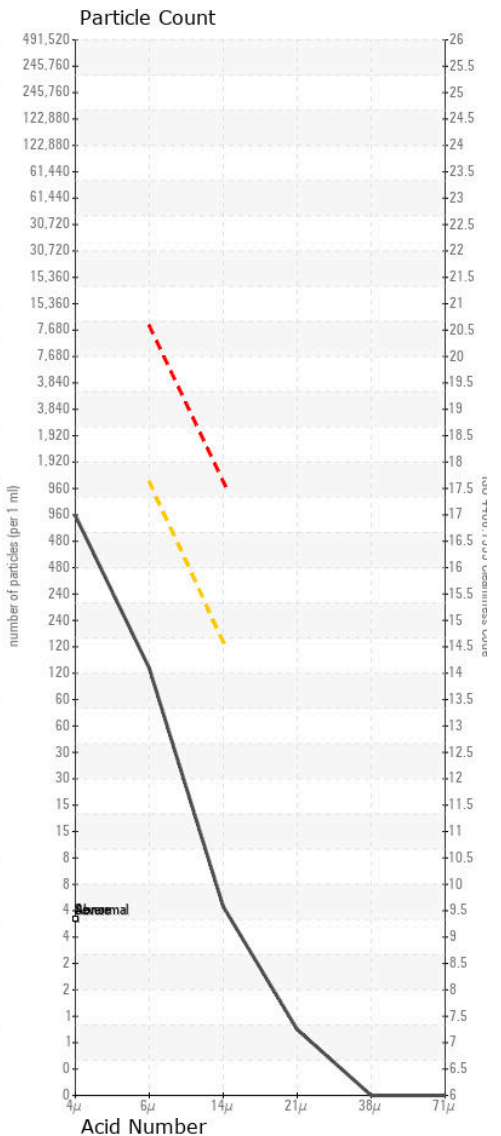
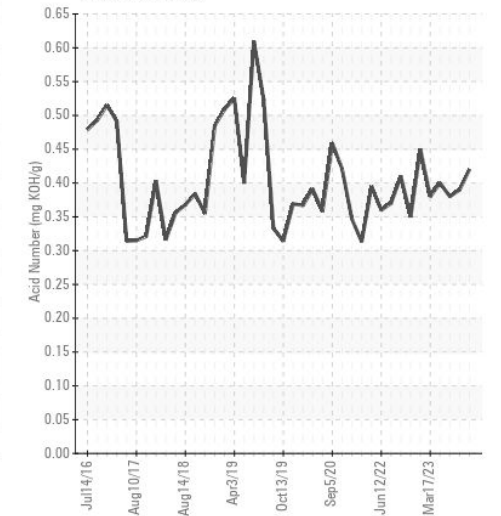
All component wear rates are normal.

The amount and size of particulates present in the system are acceptable. There is no indication of any contamination in the oil.

The AN level is acceptable for this fluid. The condition of the oil is suitable for further service.

Resample at the next service interval to monitor.
