### LIEBHERR LH22M 112532-1250 - Rear Right Wheel Hub

Sample No: LH0153187

Oil Type: LIEBHERR GEAR BASIC 90 LS

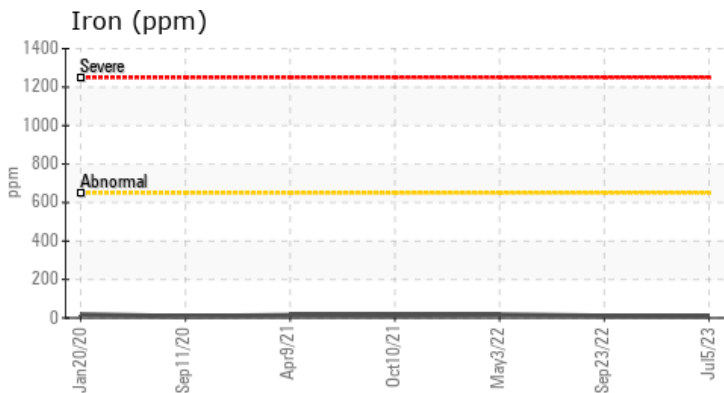
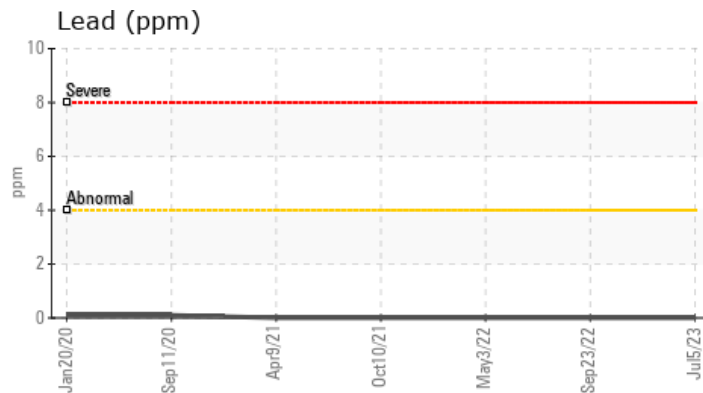
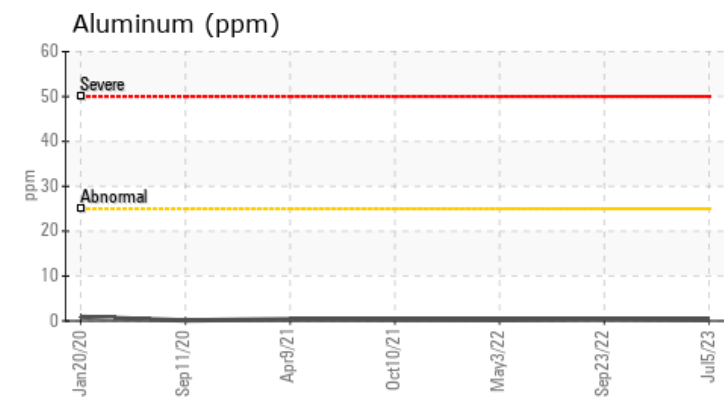
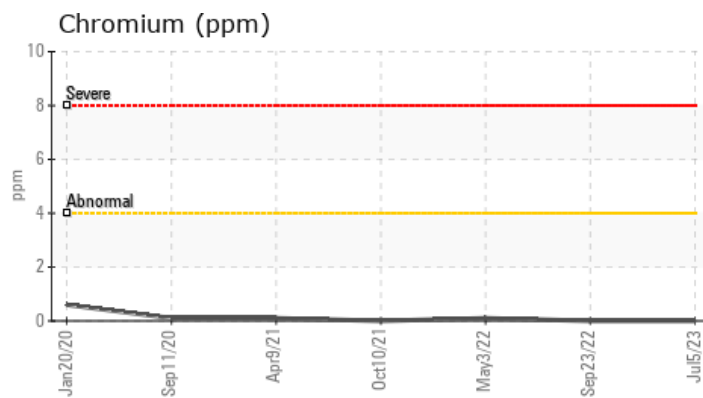
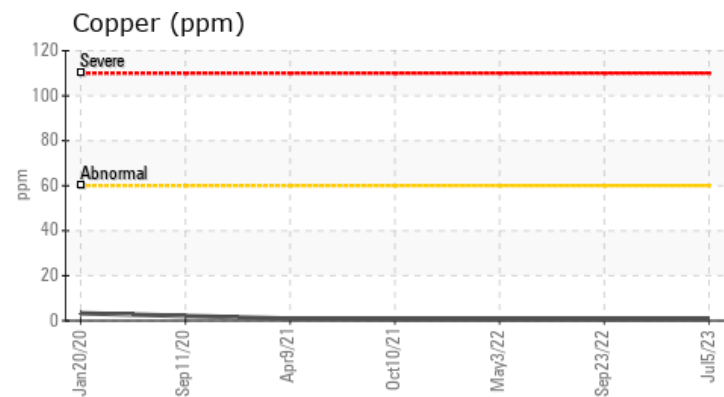
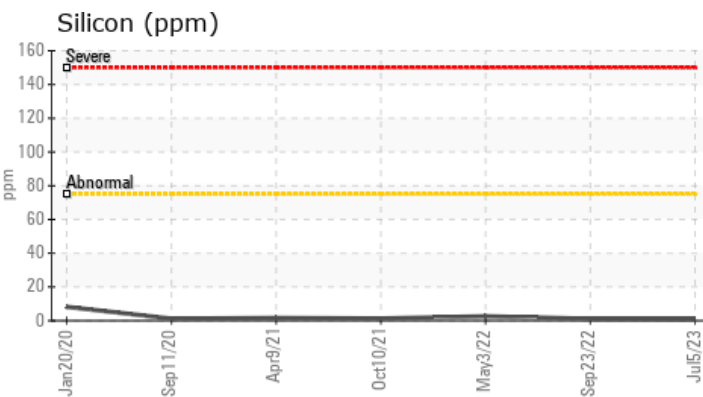
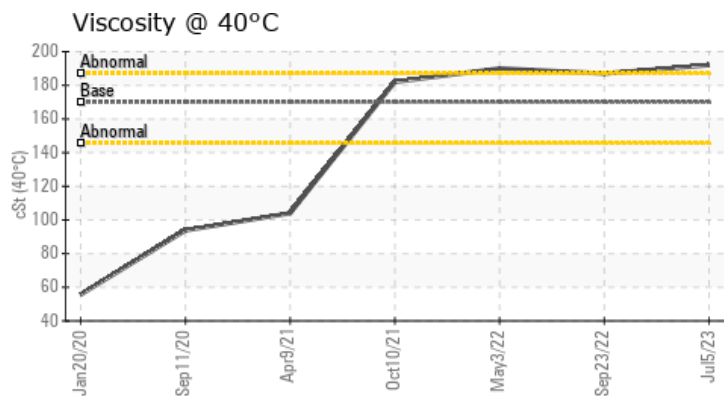
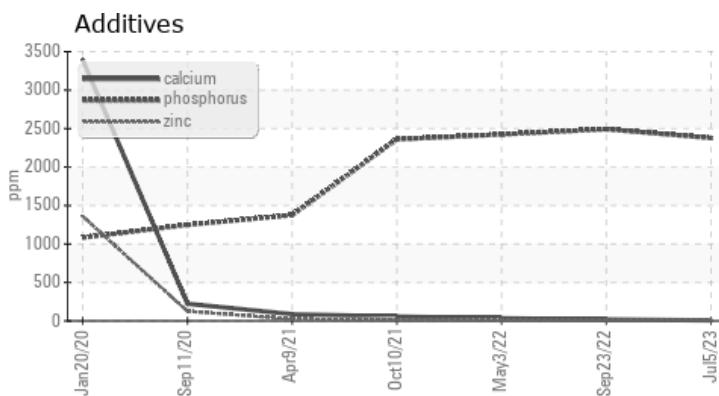
### GRAPHS

Échantillonner de nouveau l'équipement au prochain intervalle de vidange afin d'en surveiller la condition. Les taux d'usure de tous les composants sont normaux. Il n'y a aucun indice de contamination dans l'huile. L'état de l'huile est acceptable pour la durée de service.
