LIEBHERR A924 018457-957 - Rear Right Wheel Hub

Sample No: LH0274295

SAMPLE INFORMATION

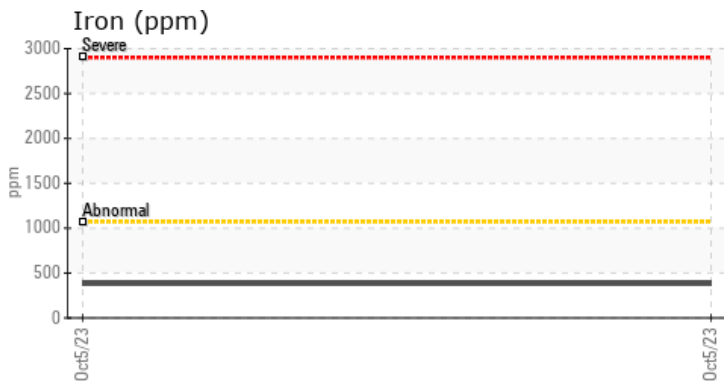
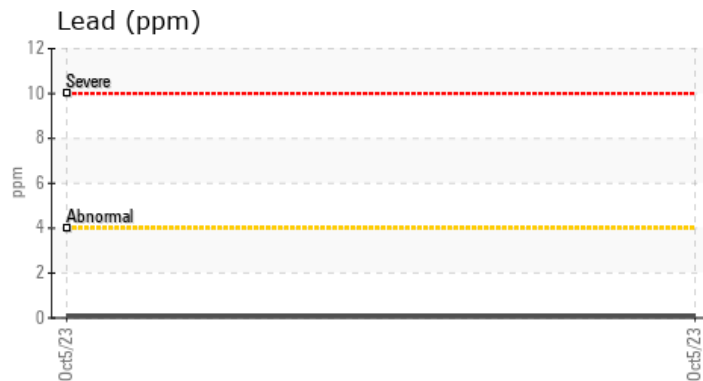
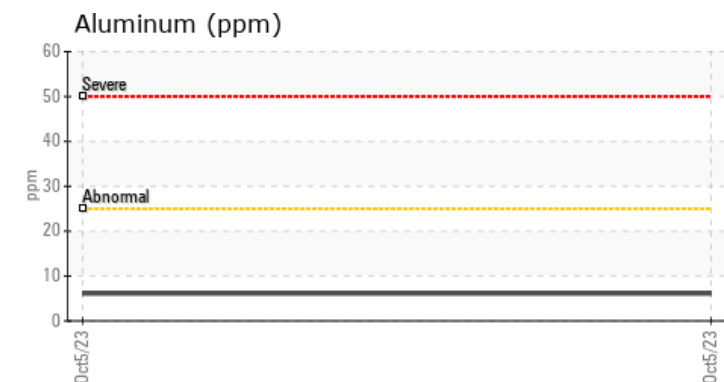
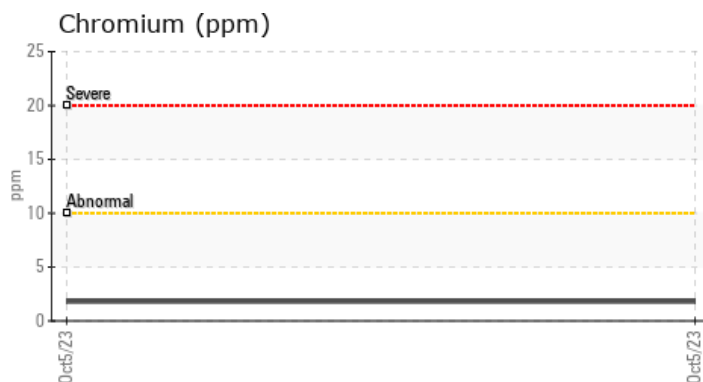
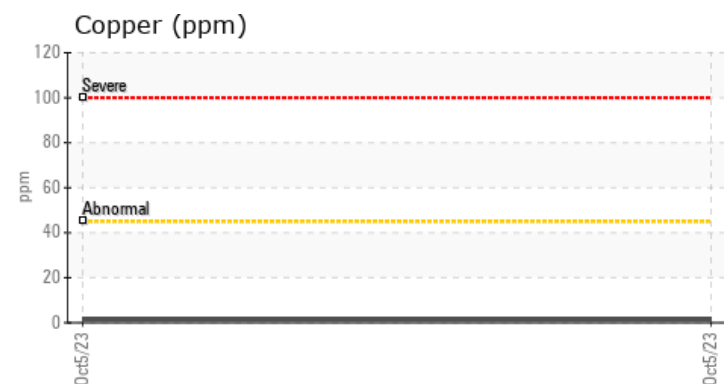
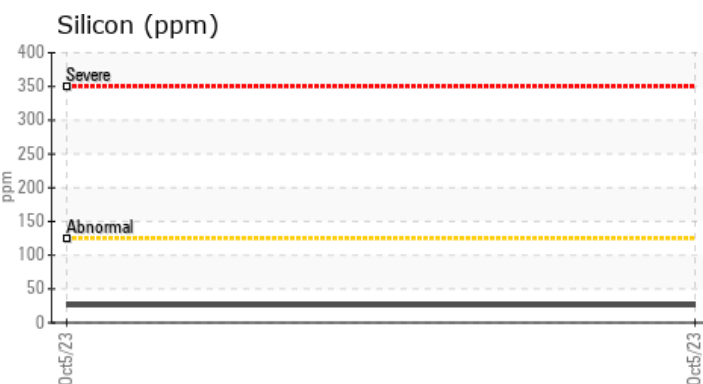
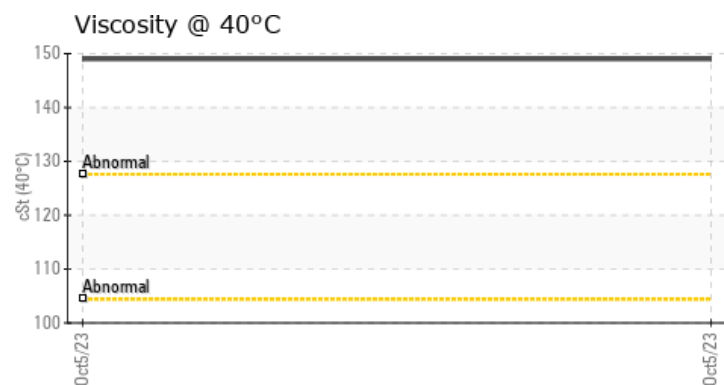
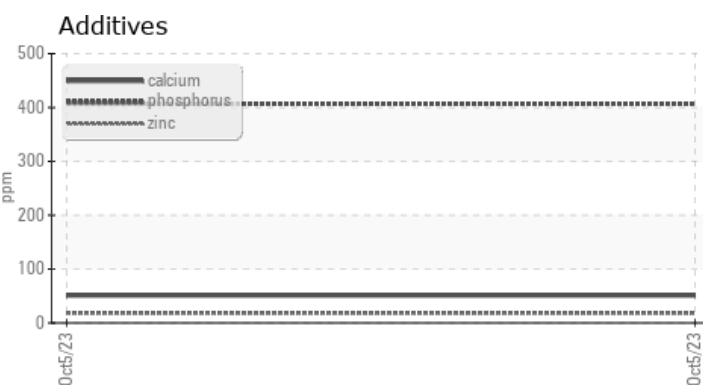
GRAPHS

Iron	ppm	381	---	---	---
Copper	ppm	1	---	---	---
Lead	ppm	<1	---	---	---
Tin	ppm	0	---	---	---
Aluminum	ppm	6	---	---	---
Chromium	ppm	2	---	---	---
Molybdenum	ppm	5	---	---	---
Nickel	ppm	<1	---	---	---
Titanium	ppm	0	---	---	---
Silver	ppm	<1	---	---	---
Manganese	ppm	2	---	---	---
Vanadium	ppm	0	---	---	---

Nous vous recommandons de vérifier la présence de particules métalliques visibles dans l'huile. Nous vous recommandons de vidanger l'huile de ce composant si vous ne l'avez pas déjà fait. Nous vous recommandons d'échantillonner de nouveau dès que possible afin de contrôler la situation. Présence d'une concentration moyenne de métal visible. Usure des engrenages. Il n'y a aucun indice de contamination dans l'huile. l'huile n'est plus en état de service en raison d'une usure anormale et/ou sévère.
