## LIEBHERR L586 068244 - Splitter Box

Sample No: LH

Oil Type: PETRO CANADA TRAXON SYNTHETIC 75W90

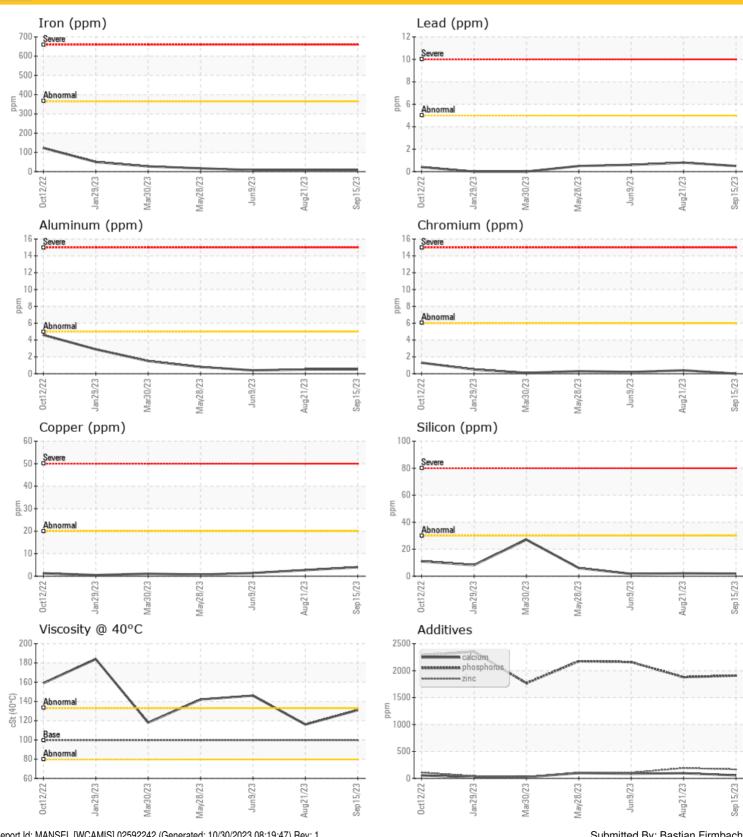
#### **GRAPHS**

Confirm the source of the lubricant being utilized for top-up/fill.
Resample at the next service interval to monitor.All component wear rates are normal. There is no indication of any contamination in the oil. Additive levels indicate the addition of a different brand, or type of oil. The condition of the oil is acceptable for the time in service.
