## LIEBHERR L586 053090-1334 - Final Drive

Sample No: LH0287069
Oil Type: {unknown}

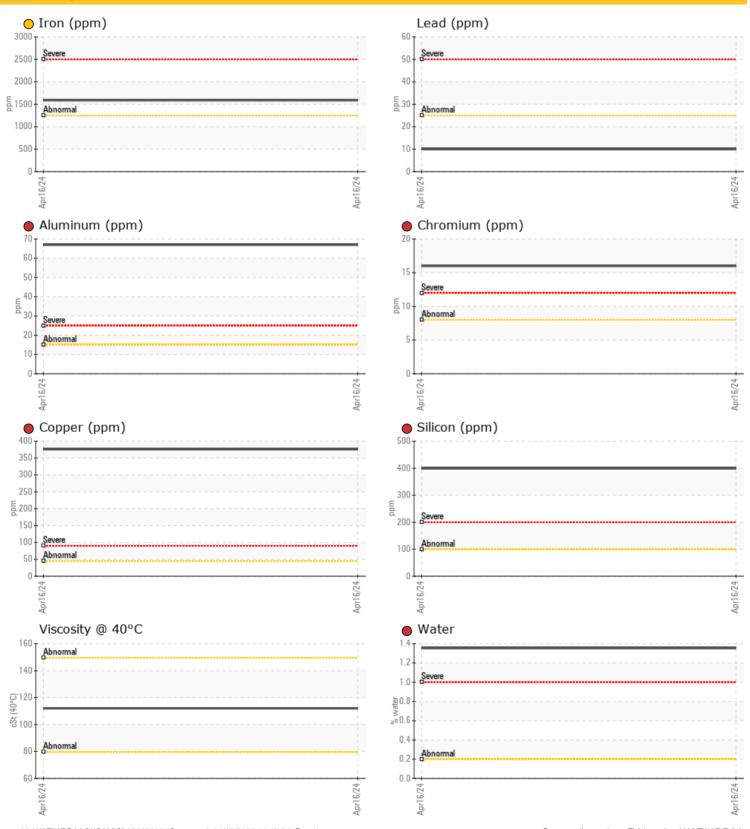
## **Graphs**

_				
O Samu	le Informa	<b>It</b> ion		
	ie informo			
Sample Number		LH0287069	 	
Sample Date		16 Apr 2024	 	
Machine Hours		10149	 	
Oil Hours		0	 	
Oil Changed		Changed	 	
Sample Status		SEVERE	 	
Oil Co	ndition			
Visc @ 40°C	cSt	112	 	
Visc @ 100°C	cSt	15.9	 	
Viscosity Index (VI)	Scale	151	 	
-4				
Conto	mination			
Water	%	<b>1.354</b>	 	
Silicon	ppm	<b>399</b>	 	
Sodium	ppm	<b>6</b>	 	
Potassium	ppm	<b>40</b>	 	
(Ö)				
Wear	r Metals			
PQ		<b>460</b>	 	
Iron	ppm	O 1590	 	
Copper	ppm	376	 	
Lead	ppm	O 10	 	
Tin	ppm	<b>27</b>	 	
Aluminum	ppm	67	 	
Chromium	ppm	0 16	 	
Molybdenum	ppm	0	 	
Nickel	ppm	<b>2</b>	 	
Titanium	ppm	5	 	
Silver	ppm	0	 	
Manganese	ppm	22	 	
Vanadium	ppm	<1	 	
Addit	lives			
Calcium	ppm	928	 	
Magnesium	ppm	430	 	
Zinc	ppm	89	 	
Phosphorus	ppm	1995	 	
Barium	ppm	0	 	
Boron	ppm	44	 	
20.011	PP111

We advise that you check for the source of water entry. We advise that you check all areas where dirt can enter the system. The oil change at the time of sampling has been noted. We recommend an early resample to monitor this condition. Please specify the brand, type, and viscosity of the oil on your next sample. Aluminum and chromium and copper and tin ppm levels are severe. PQ levels are severe. Iron ppm levels are abnormal. Gear wear is indicated. Bearing and/or bushing wear is indicated. The very high ferrous density (PQ) index indicates that severe wear is occurring. There is a high concentration of water present in the oil. High concentration of dirt present in the oil. High amount of ingressed dirt has caused abrasive wear to the component. The oil is no longer serviceable as a result of the abnormal and/or severe wear.
